City of Enumclaw Pool Evaluation

October, 2017

*Prepared by:
Aquatic Commercial Consulting
Richard A. Young, Aquatic Consultant
408-741-5871 // richy@aquacom.us*

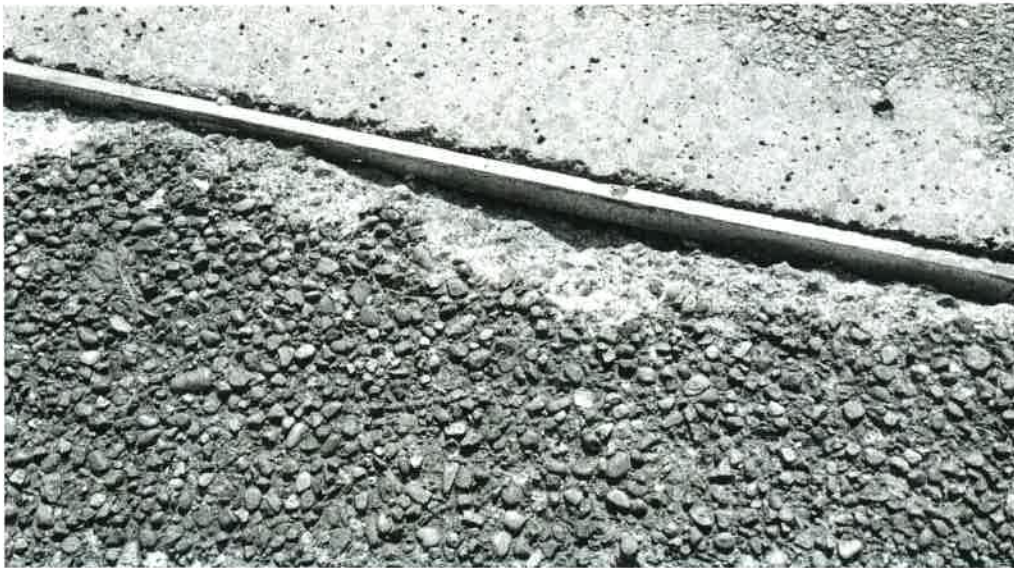
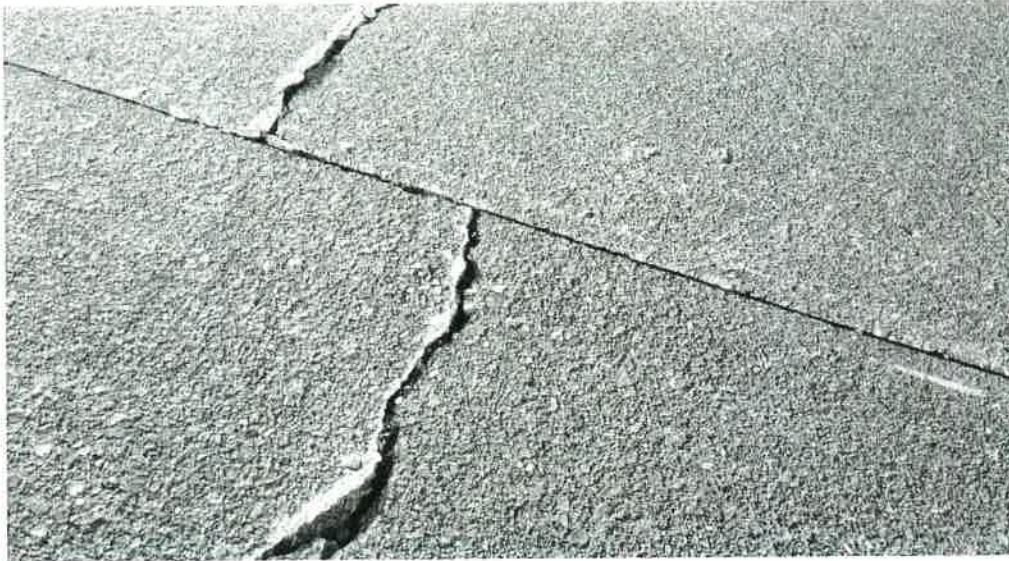
1. At present, there are no ADA compliant parking spaces near the pool entrance.
2. The facility does provide an ADA compliant ramp to the entry.
3. There are several severe concrete cracks and voids in the concrete surrounding the pool outside entrance that present a trip hazard.

2. Fill the cracks that present the tripping hazard with concrete and appropriate concrete patch. Long term, replace the concrete entry area including the steps.

Estimated Cost: Short Term Filling of Cracks with a like material to match the existing concrete surface: Nominal

Long Term: removal and replacement of the entry concrete with Cracks: \$24,000

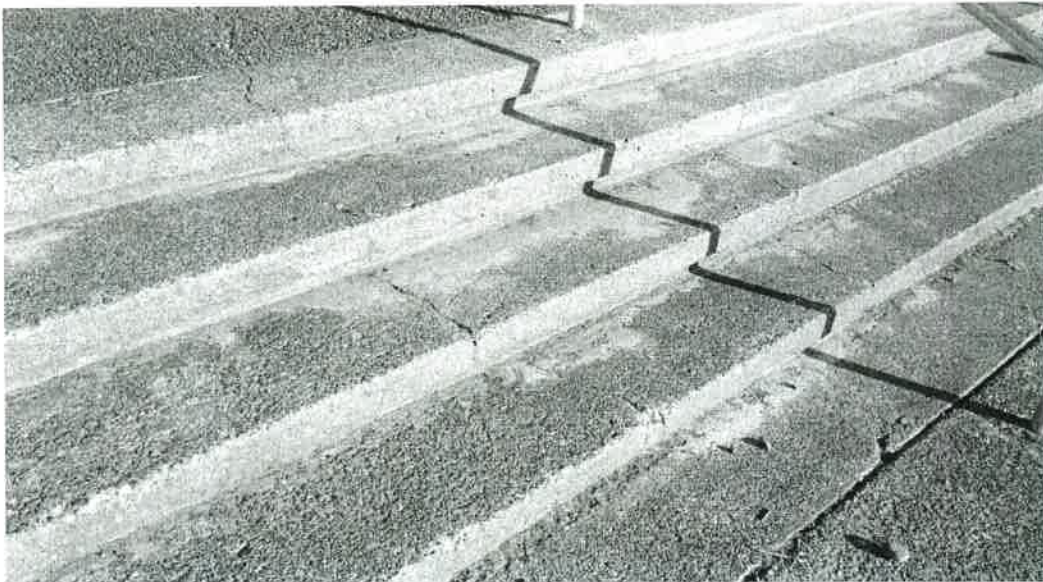
4. The steps have several cracks many of which have been patched and are somewhat unsightly.

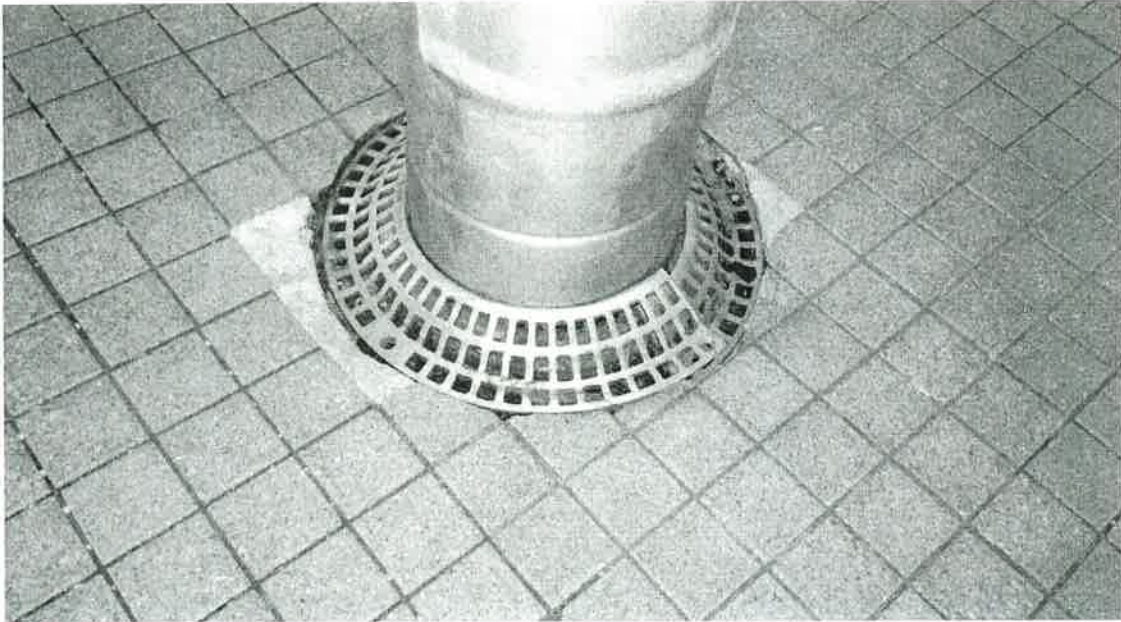
3. The tile and drains immediately around the bases of the shower posts have failed and the drains are loose.

Recommendation: Complete replacement of the missing tile and properly secure the drain with stainless steel screws.

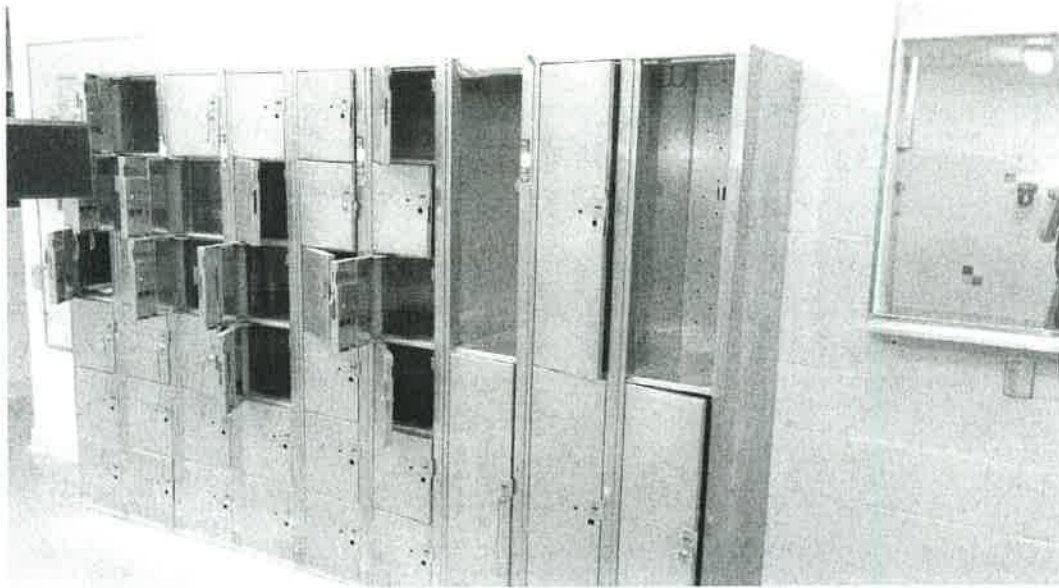
4. The existing stainless steel lockers are of various sizes, in reasonable condition, but are missing many of the locks and several doors. Staff reports new fixtures and doors are being pursued.

Recommendation: These lockers are in good condition but are requiring Replacement locks and several locker doors. Replace the locks and doors as required.

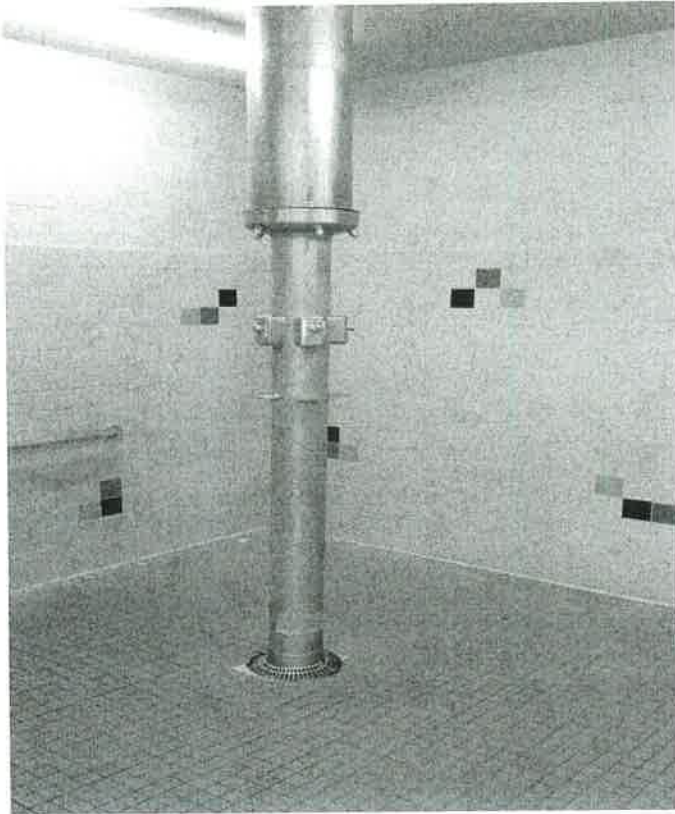
5. There is no compliant ADA shower in the men's locker room, however, staff reports the women's shower area is fitted with a hand held shower and bench. The existing shower handles are too high for wheel chair bound patrons.

Recommendation: Retrofit at least one shower nozzle to a hand held shower head with an operating handle on the flexible head.

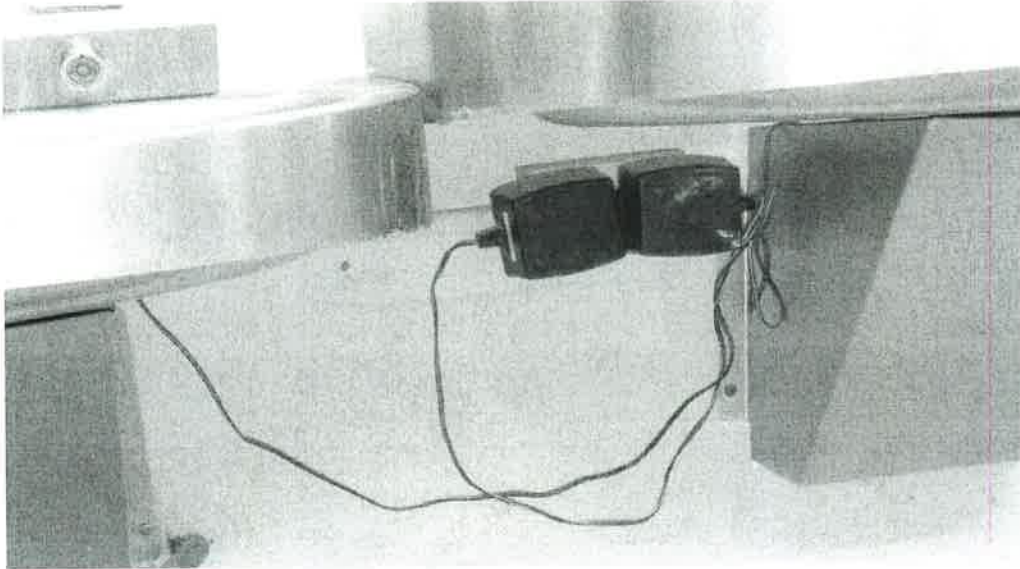
7. There is an ADA compliant drinking fountain, however, the units plug into a non-GFCI wall receptacles. This does not comply with WAC or NEC.

Recommendation: Install an appropriate GFCI receptacle.
Estimated Cost: \$100

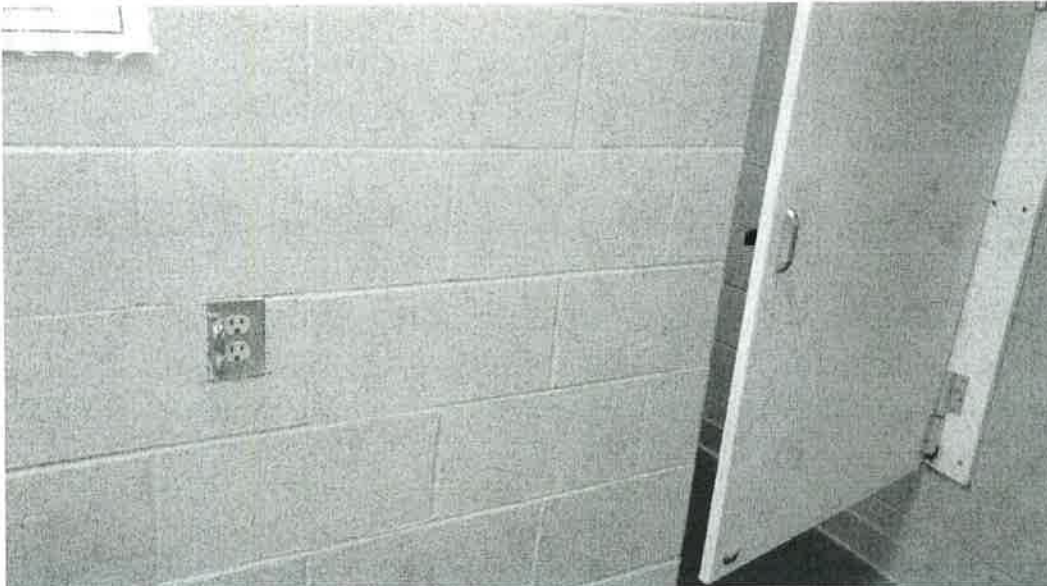
8. There are other non-compliant electrical receptacles that are not GFCI protected.

Install appropriate GFCI receptacles or install a GFCI breaker and appropriately label the receptacle that it is GFCI protected.

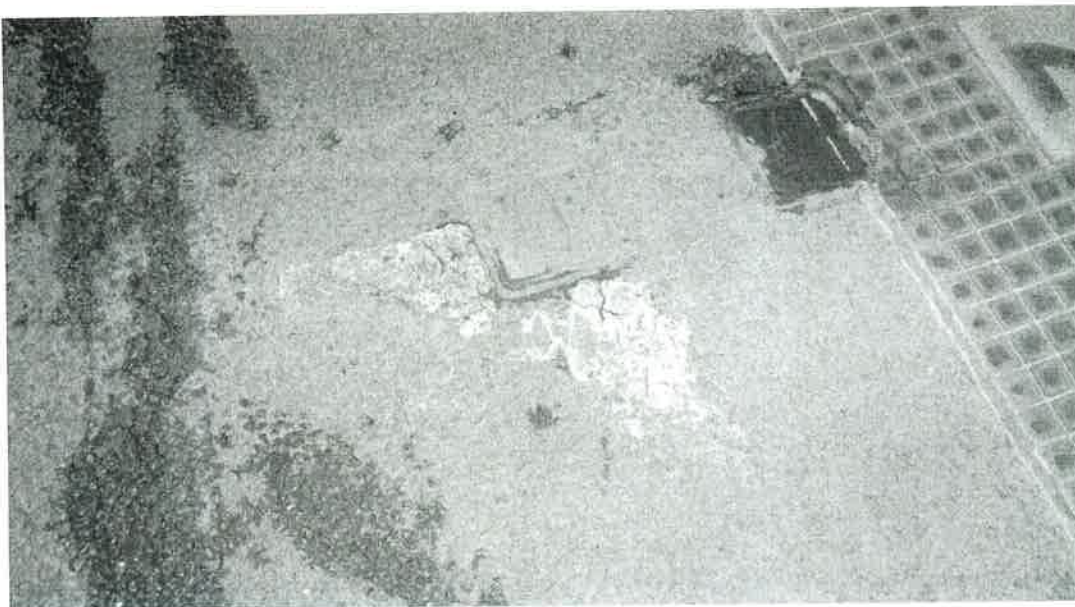
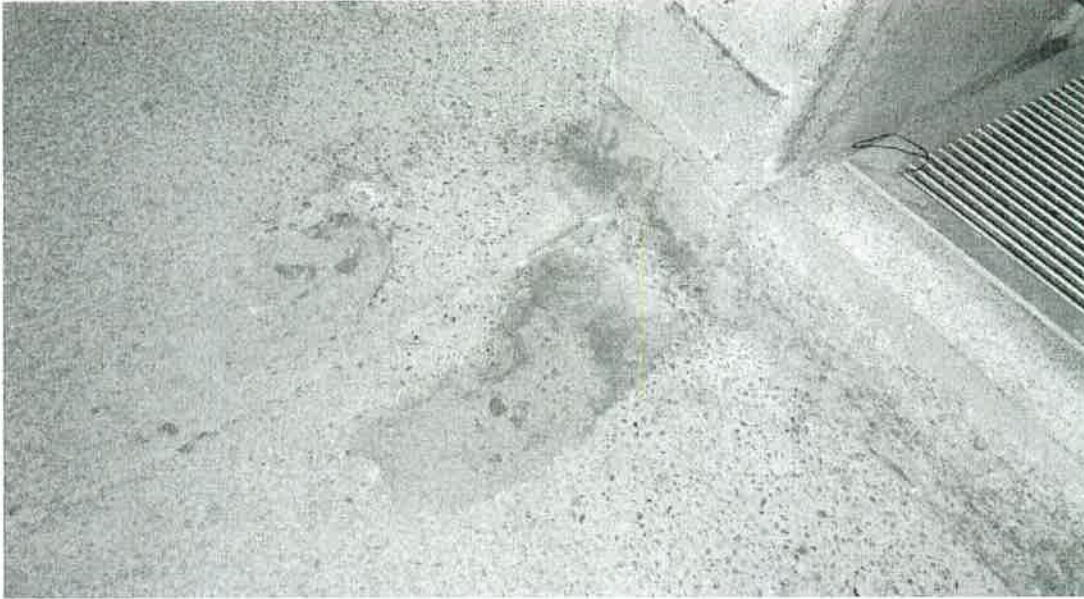
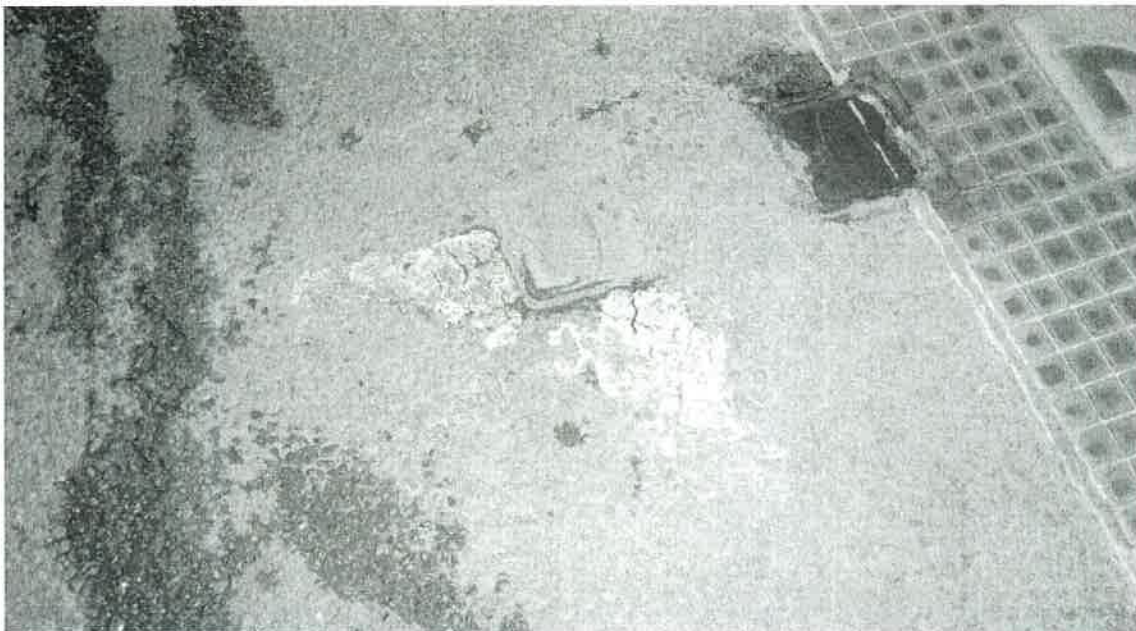
1. The deck is tired. There are many areas that harbor deck cracks, voids, significant unsightly stains or deck patches. There is approximately 5,500 square feet of deck and seating area.

- Short term:
1. Fill any cracks or voids that present a trip hazard
 2. Install covers on all anchorage not being used.
 3. Tighten loose grab rails. Install new anchor wedges if necessary
 4. Repair / level the gutter deck box cover

Long term: 1. Replace the entire deck with new deck anchorage for all the deck equipment, install a new deck drain, new tile, new safety signage new dive standard anchors. Include spectator area.

2. OPTION: Make repairs to all deck anchors, replace broken and missing tiles, level deck to be ADA compliant. Repair failing concrete area by exposing the rusting steel and epoxy coat, patch all concrete failure areas. Move diving stand. Install epoxy, slip resistant coating to all deck surfaces.

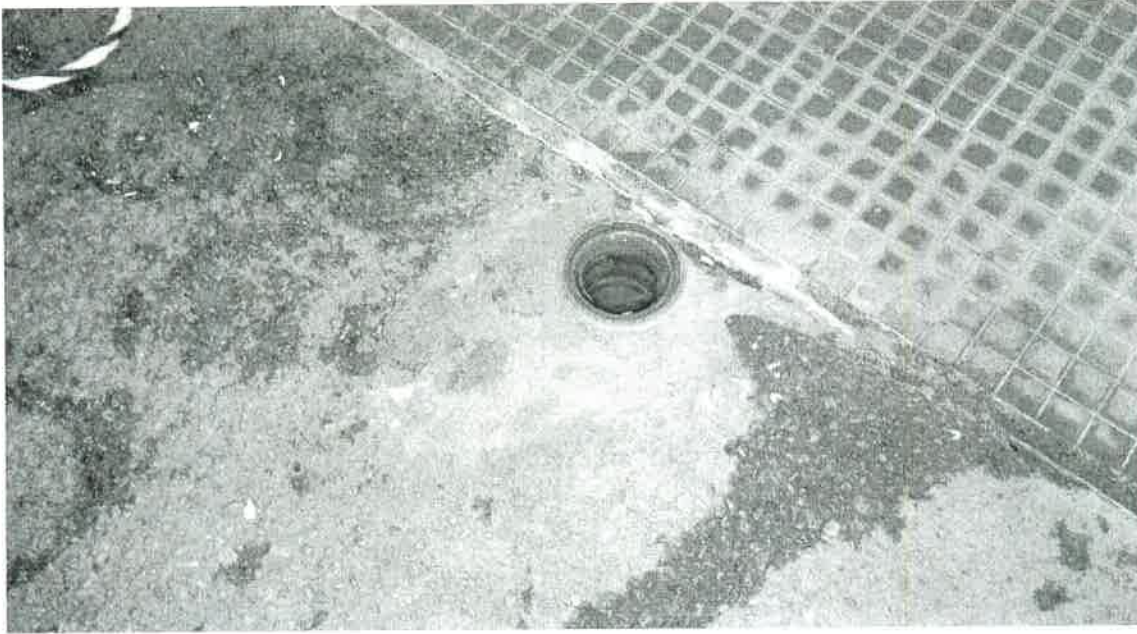
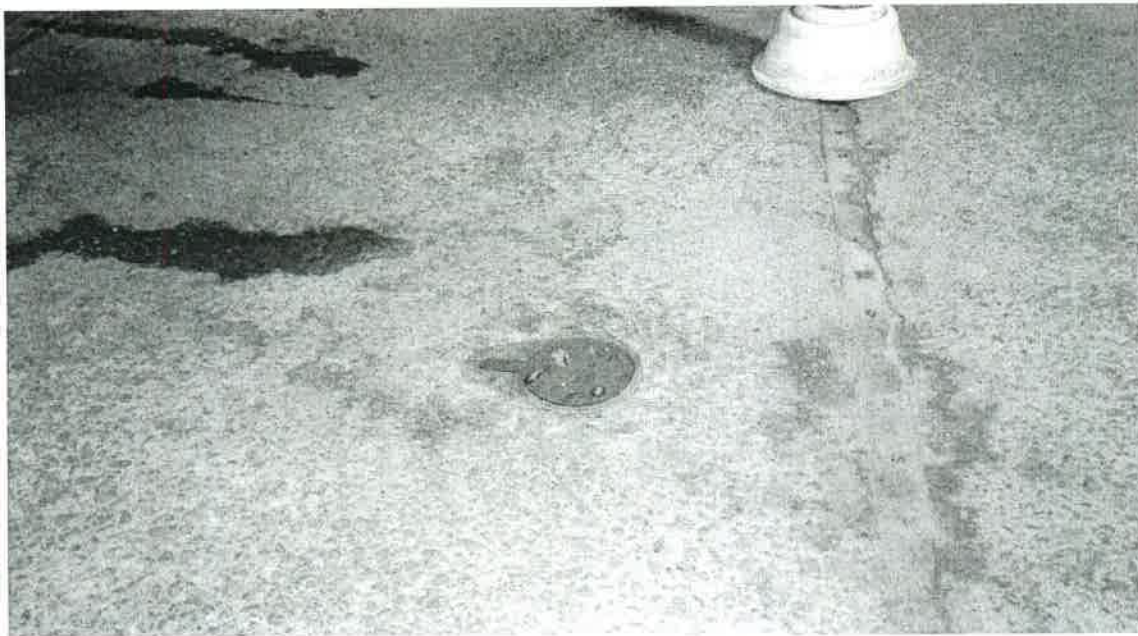
2. Many of the existing deck anchors have been abandoned with many others still in use that do not have covers and present a “toe-stub” hazard. It is worthy to note that the diving platform anchors are still in place in the shallow end. Staff reports they have not been used. Most all swimming sanctioning agencies call for a minimum of 6 feet of water for racing lane dive stands.

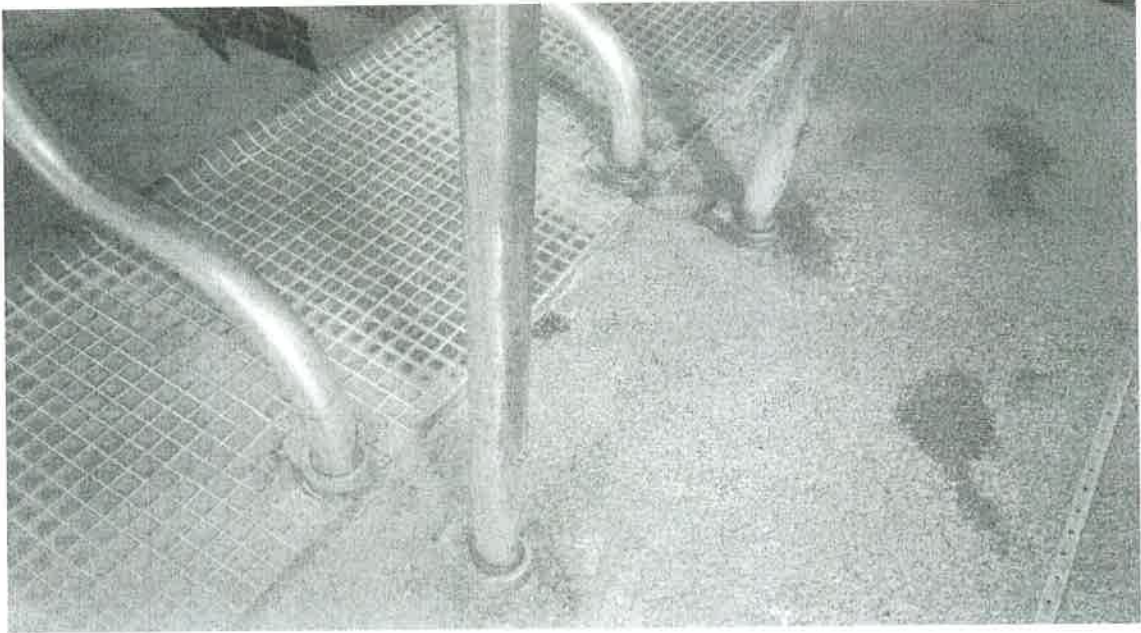
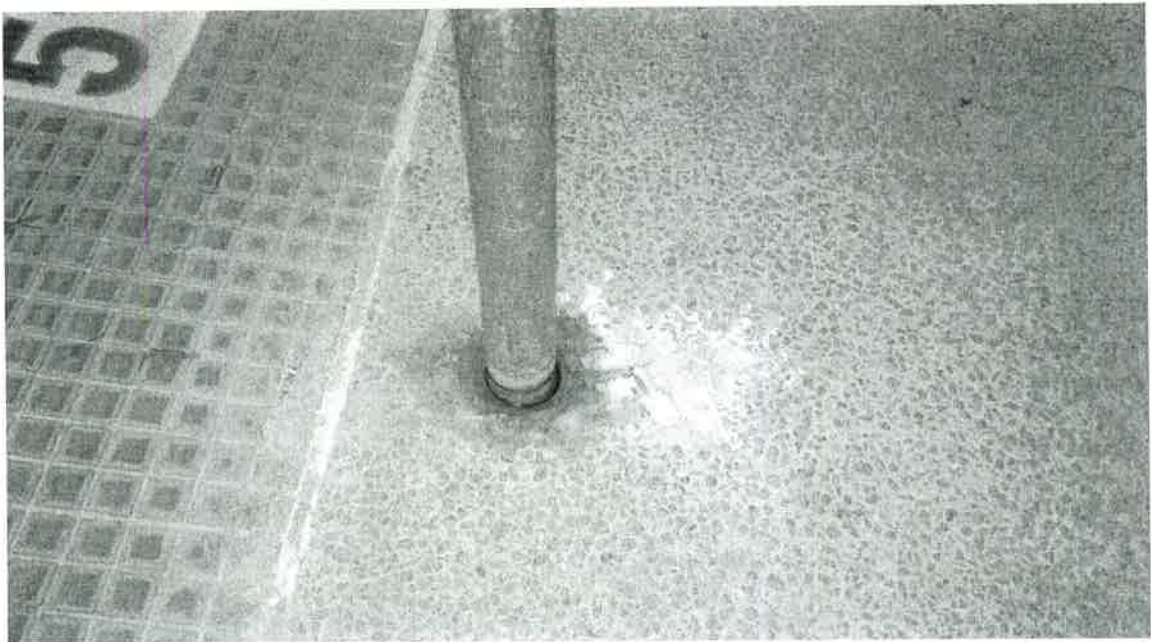
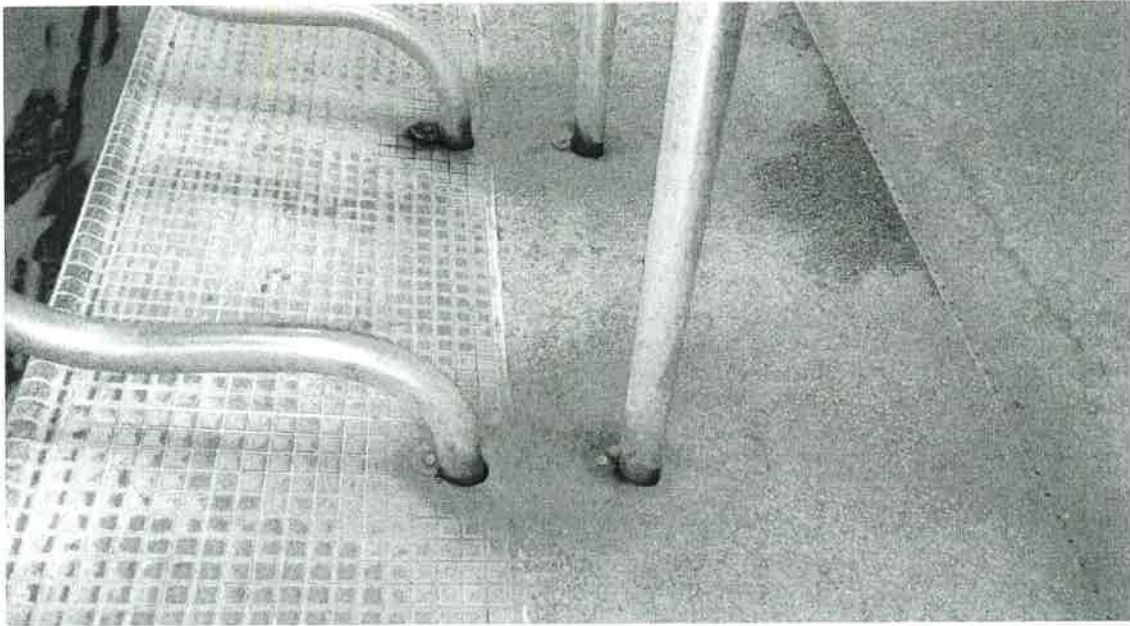
3. Several of the pool handrail anchors show significant rust staining and may have been fitted with something other than bronze or stainless steel fasteners. They are unsightly and many are missing parts.

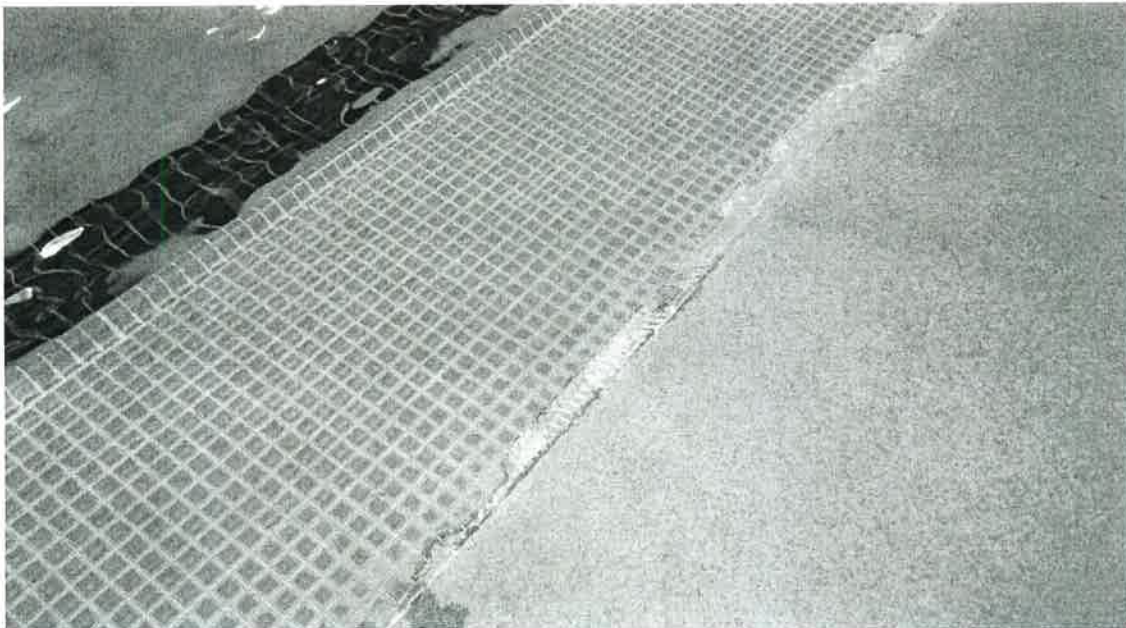
4. Several of the handrails are loose and are not in compliance with WAC and IS.
5. The expansion joint between the tile and the deck is failing in several areas.

5. Replace missing and cracked tile
6. Replace failing expansion joint caulk
7. Install an ADA compliant drinking fountain
8. Relocate the diving board stand to provide for compliant board end to wall compliance.
9. De-scale the depth markers and no diving signage
10. Move deck toys and apparatus to provide 6' clearance per WAC
11. Have structural engineer evaluate spectator footing concrete.
12. Remove and polish all of the stainless steel grab rails, stanchion posts and lifeguard stand.

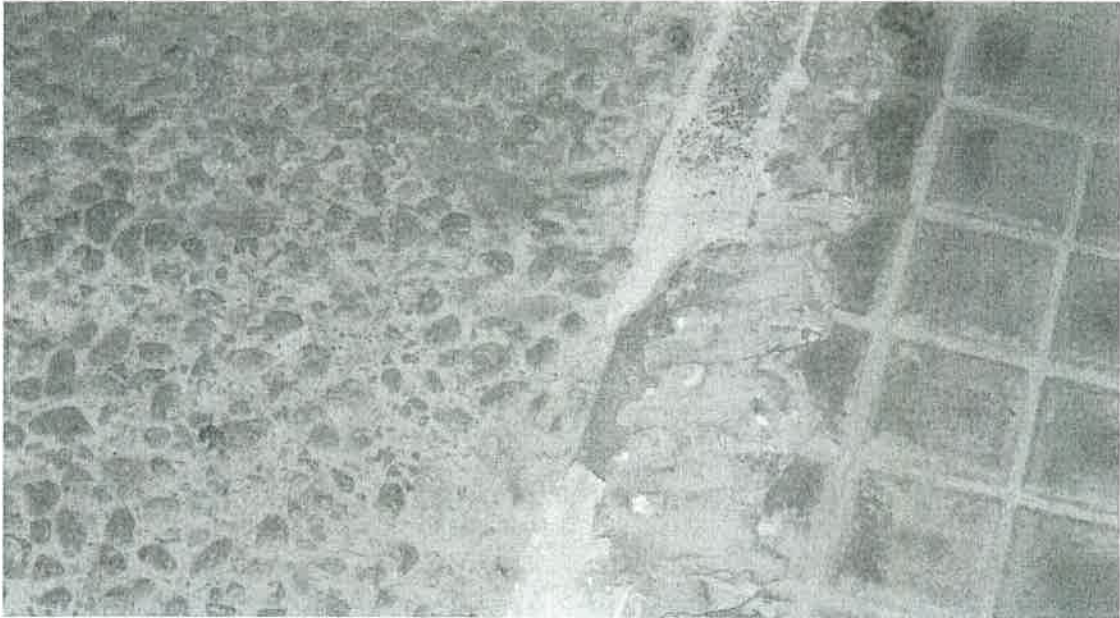
6. Many of the 1" square pool tiles are missing or are cracked around the pool edge.

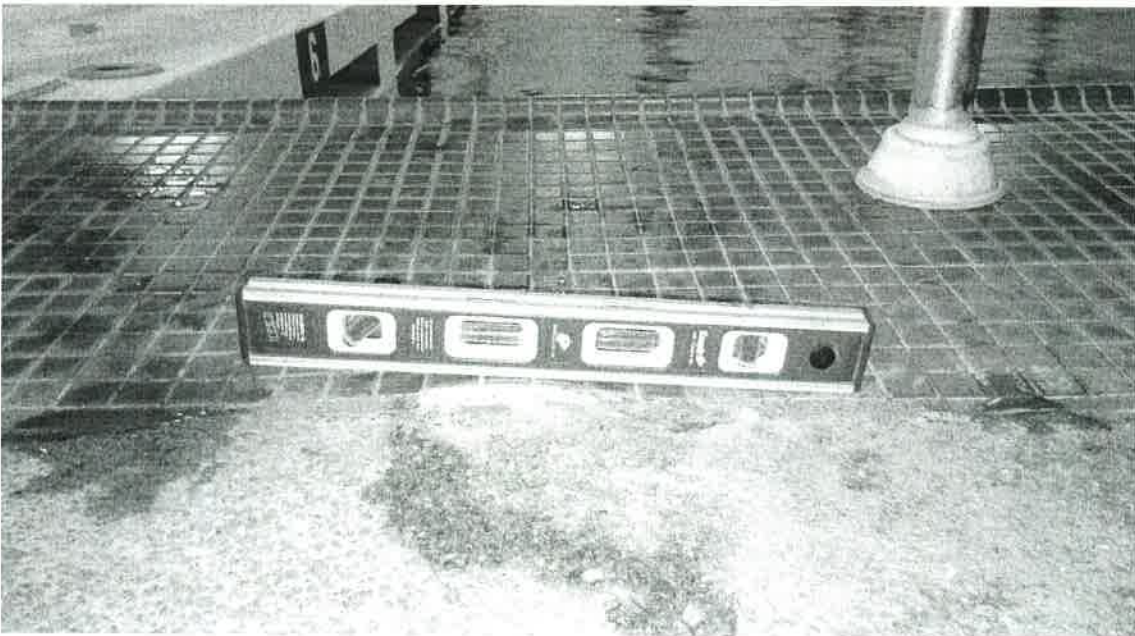
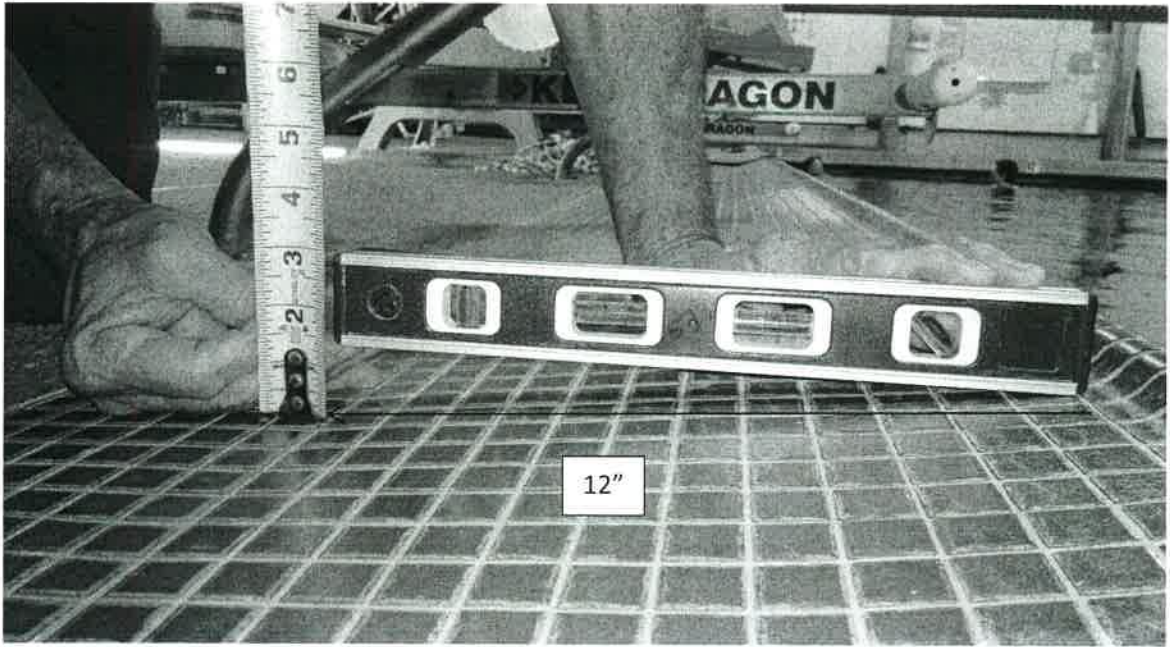
7. The tile edge around the pool has a slope significantly greater than the ADA minimum of $\frac{1}{4}$ " per linear foot and is non-compliant. In some areas the slope is more than 5 times the maximum slope.

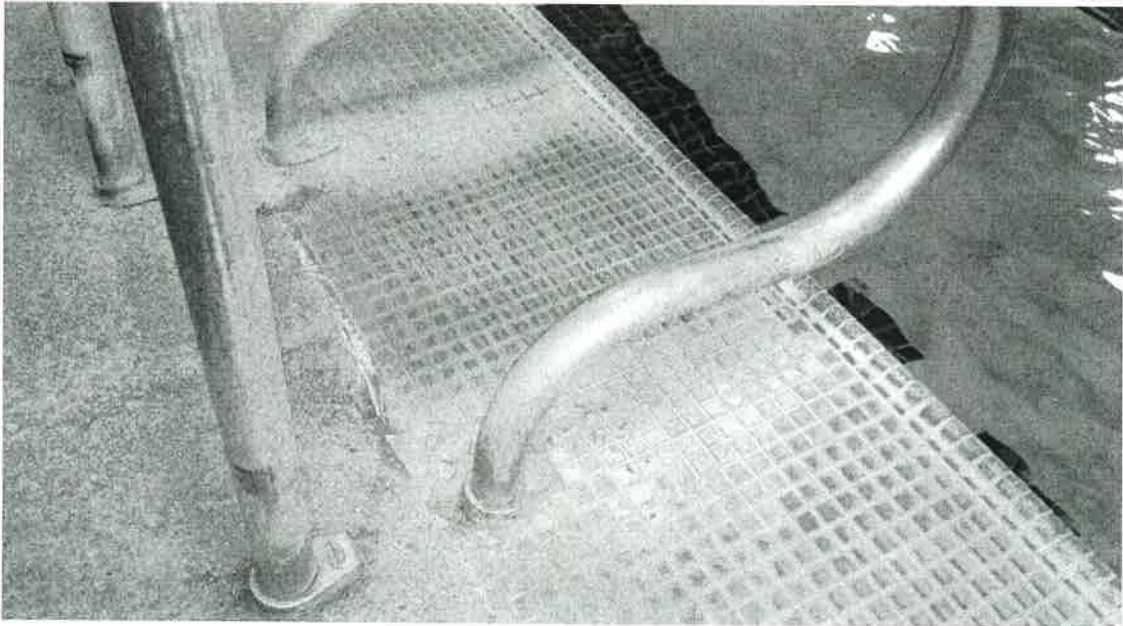
8. Most all of the tile section is well stained with calcium deposits and is unsightly.

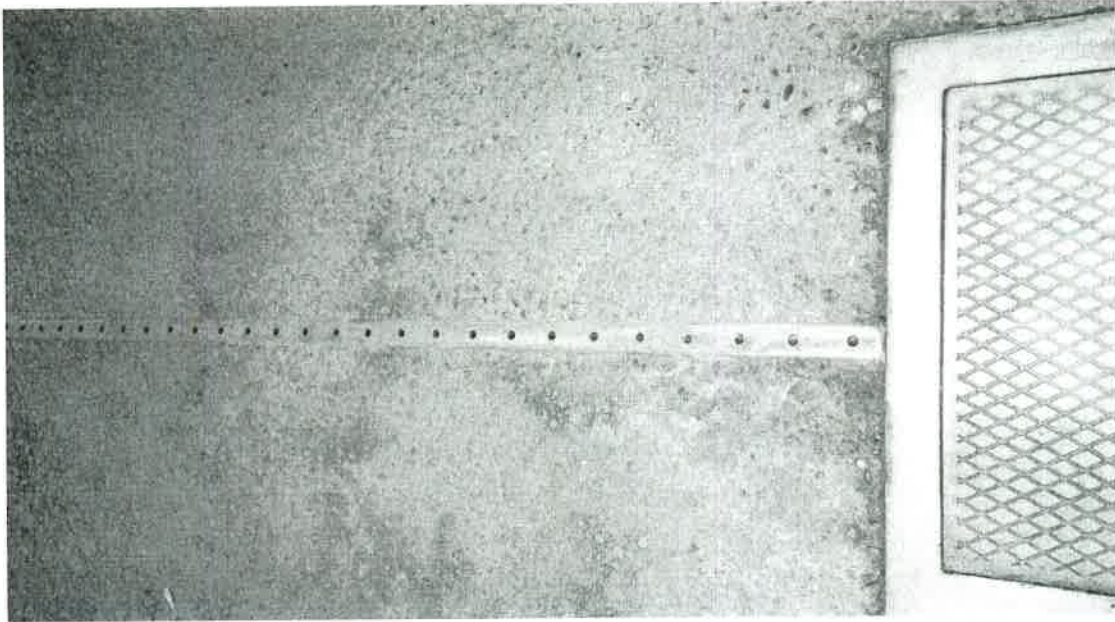
9. The stainless steel deck drain is reported by staff to function adequately for the most part, however, there were areas of standing water and the openings need cleaning.

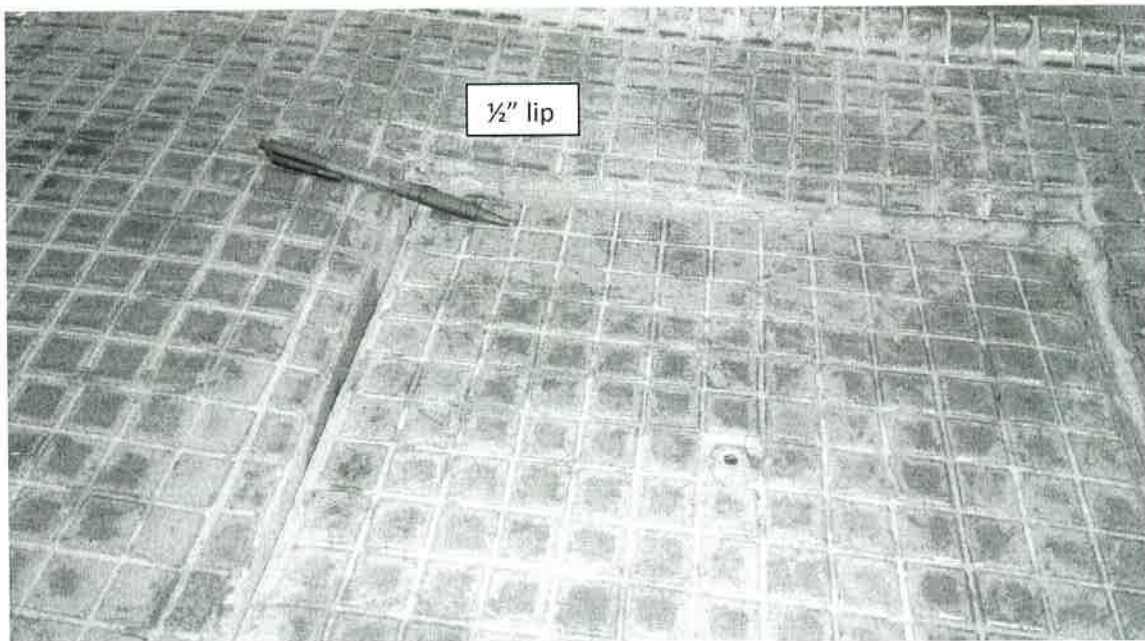
10. The cover over the gutter access port is considerably uneven with the deck and presents a trip hazard.

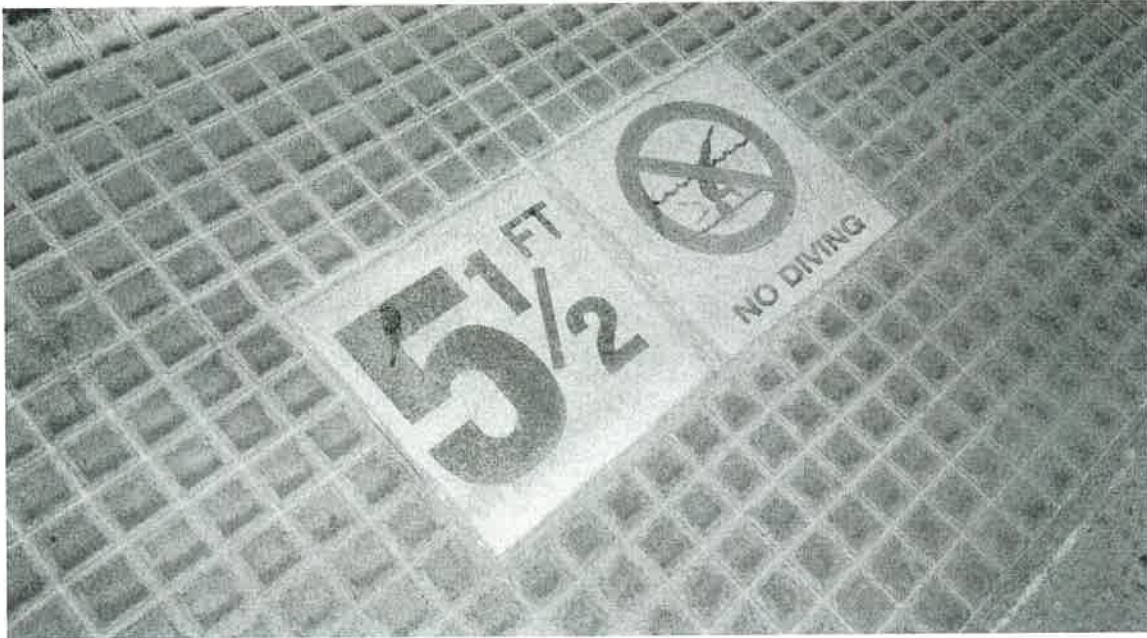
11. Several of the depth and no diving markers are considerably scaled and are unsightly.

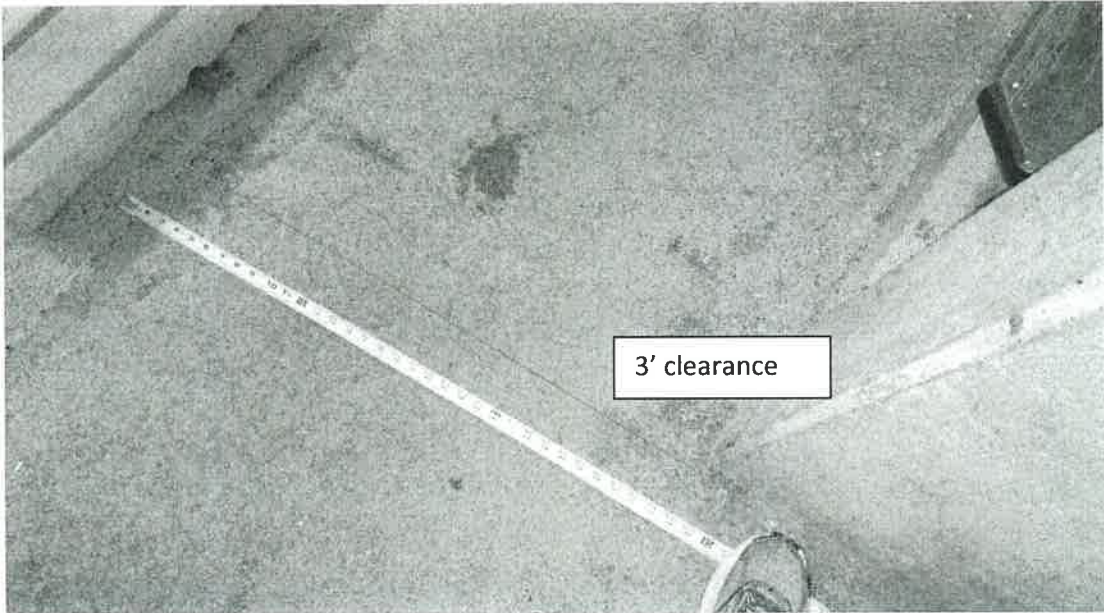
12. In some areas the deck does not comply with the WAC which requires six (6) feet of clearance. Deck apparatus such as the pool lift and the basketball hoop stand block access and provide less than three (3) feet of clearance.

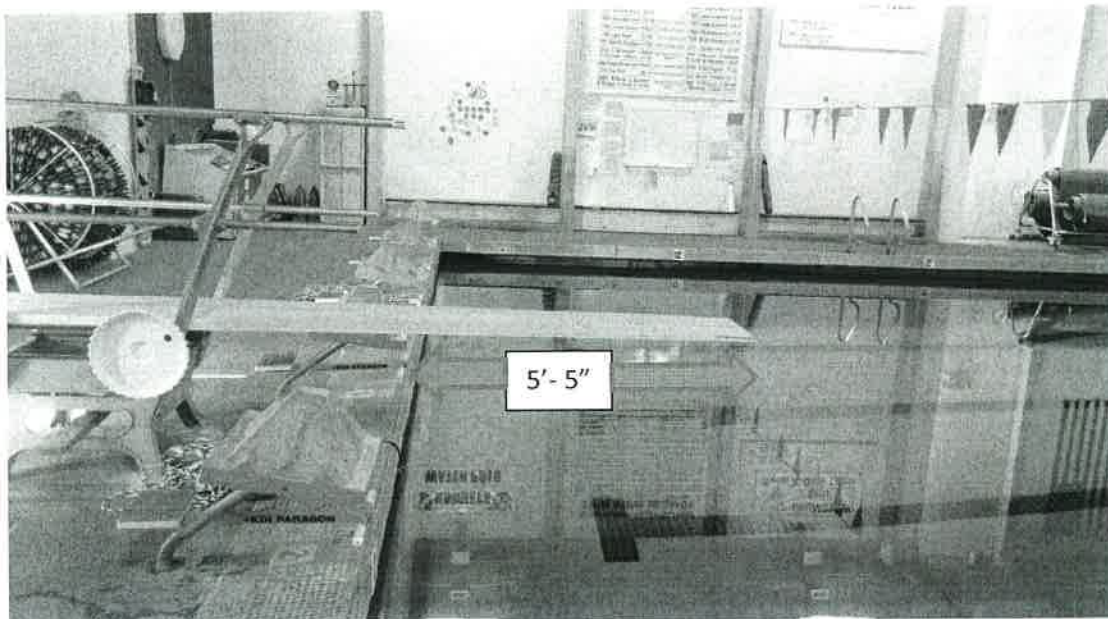
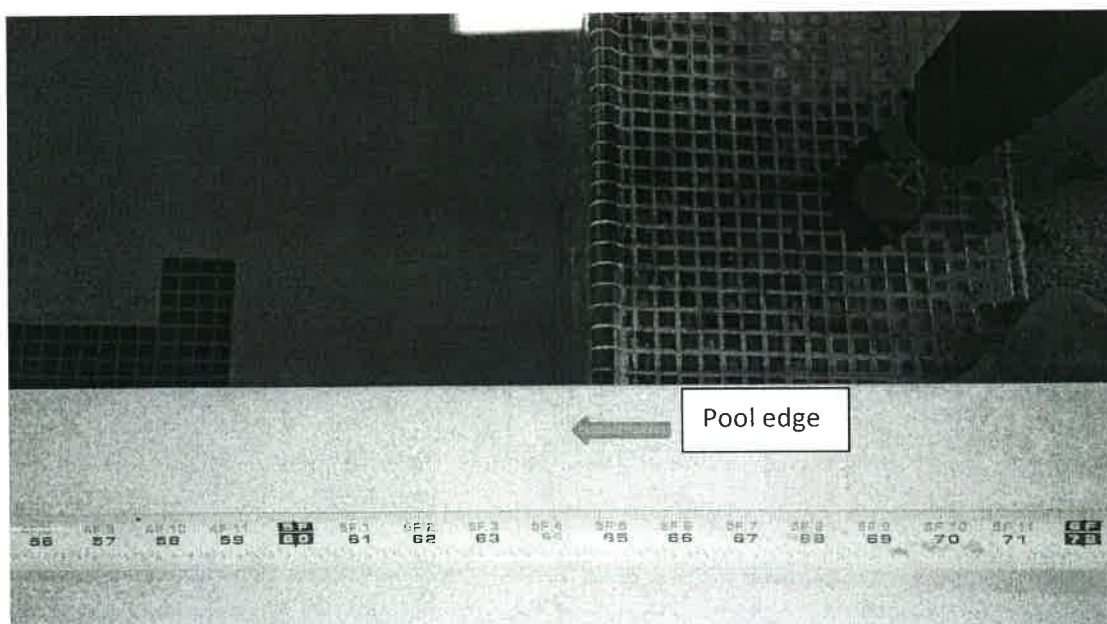
13. The diving board stand is set too far away from the pool edge and the diving board does not extend the code required six (6) feet beyond the pool edge per WAC, FIMA, NFHS

and IS. The board end is only 5'- 5" beyond the pool edge and only 5' beyond the vertical pool wall "standing" ledge.

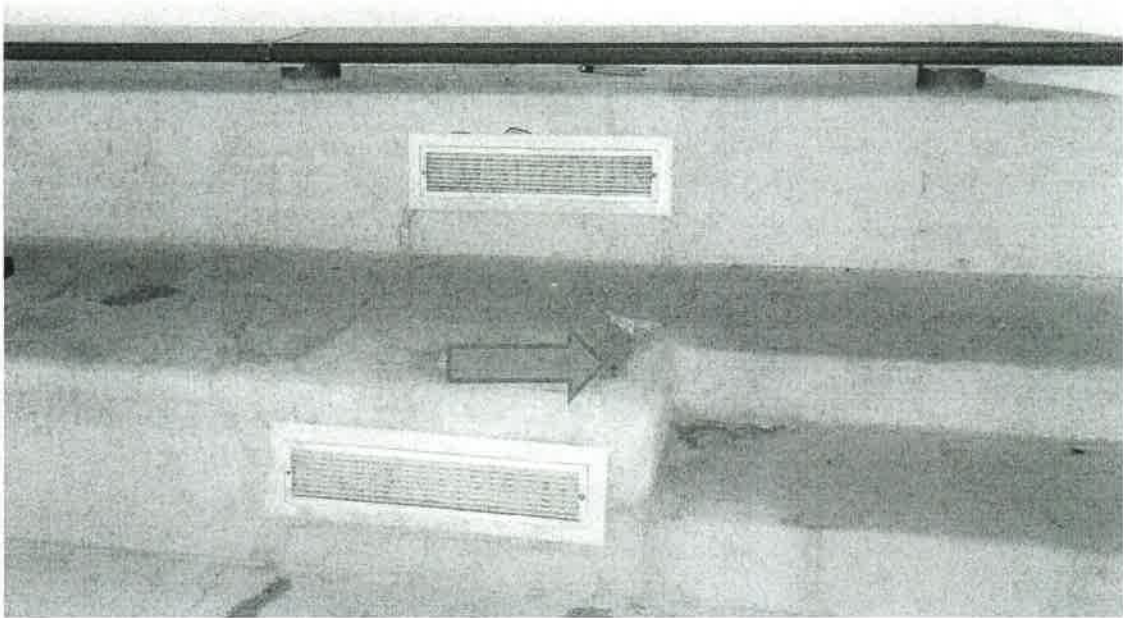
14. The seating area concrete and rail footing has failed in several areas with several cracks and voids. The seating area concrete is also cracked in several places.

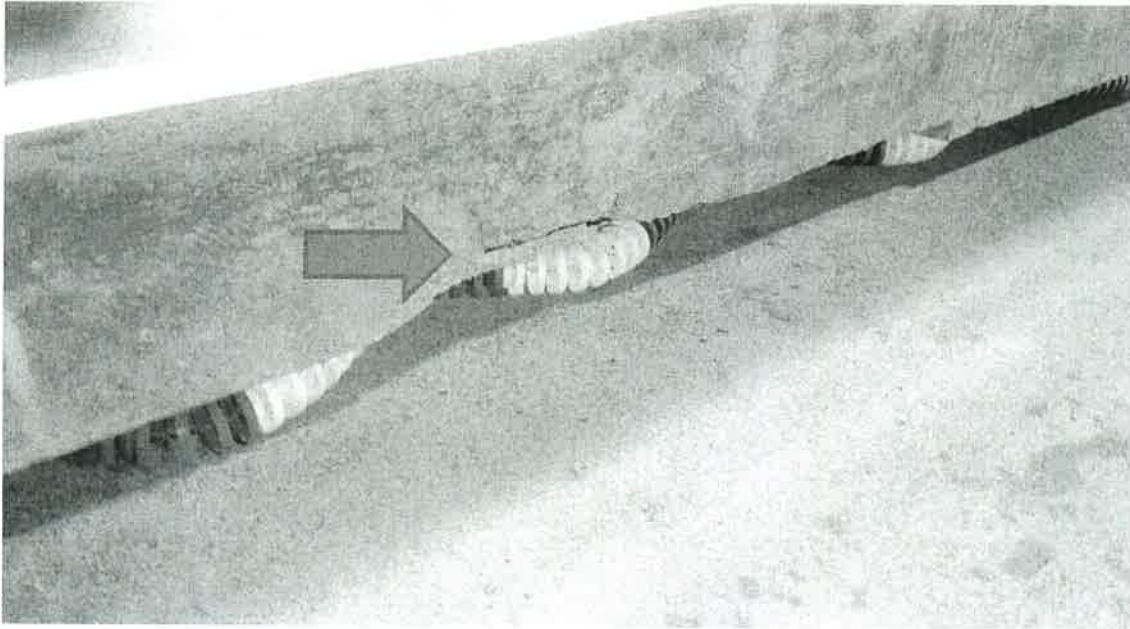
15. The concrete footing in front of the spectator area is failing and has exposed rebar.
NOTE: This failure may require a structural engineer to evaluate and make recommendations for permanent repair.

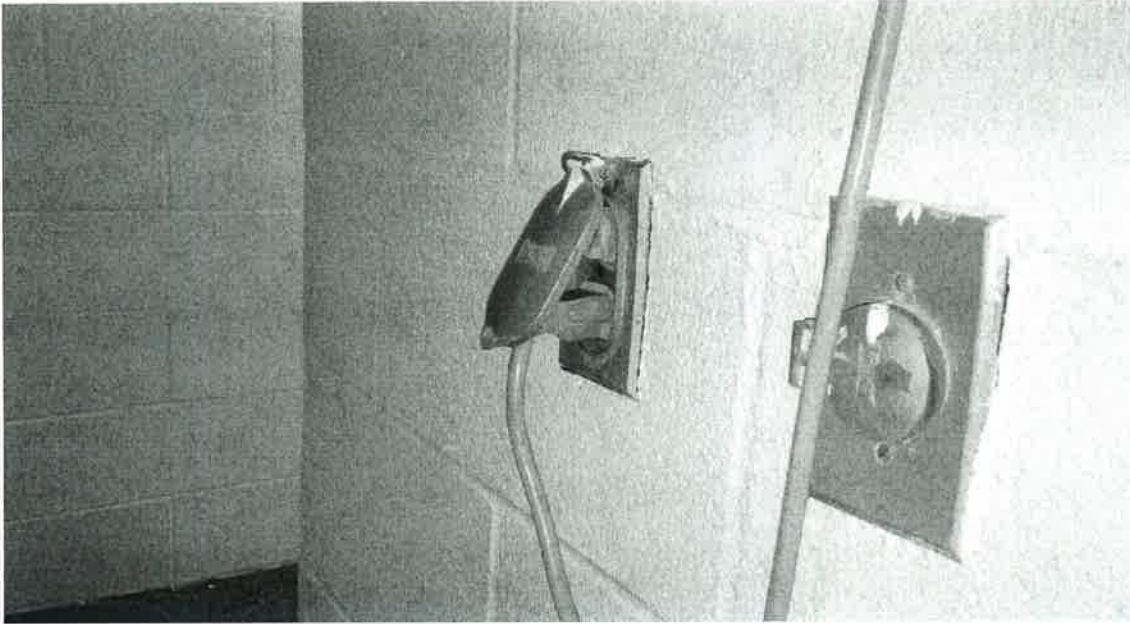
16. Several of the deck electrical receptacles are not GFCI protected per NEC, WAC and IS.

Recommendation: Install GFCI receptacles on all power locations or install a GFCI breaker in the electrical panel, placing labels on all units that they are GFCI protected.

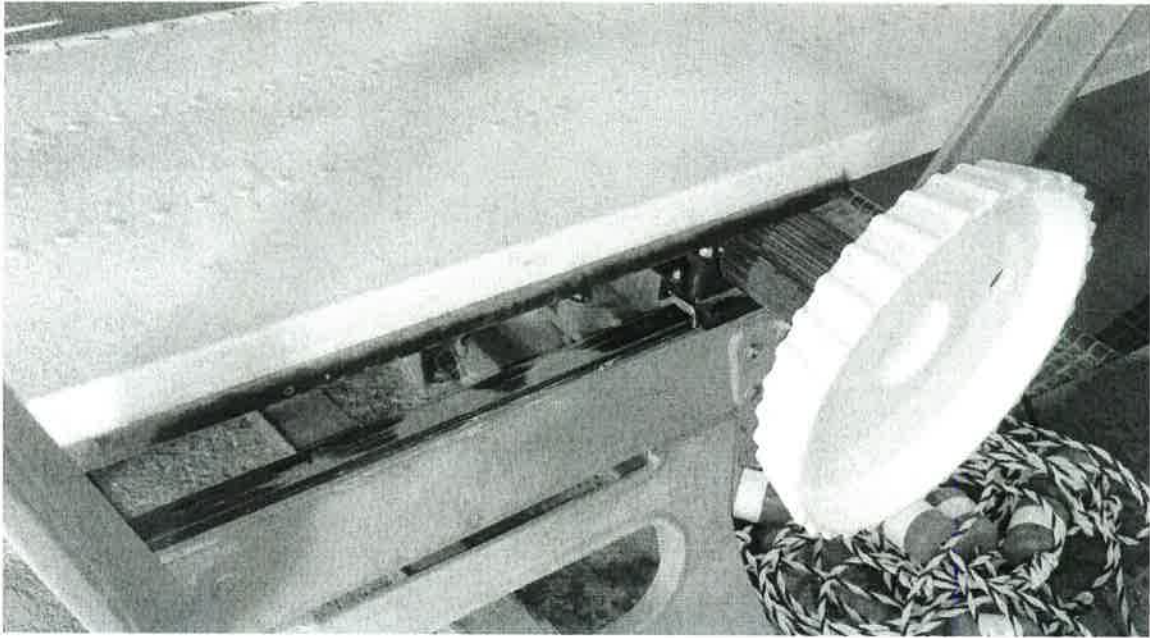
17. The diving board fulcrum and hinges do not appear to have been lubricated for some time IS.

18. The adjustable fulcrum was found to be in the forward position but is not locked in place per ARC lifeguard training manuals to prevent inexperienced users from using the board in an unsafe manner.

1. Remove and send the board back to Duraflex to have it re-surfaced
Estimated Cost: \$ 3,000
2. Lubricate the board hinges and fulcrum
Estimated Cost: Nominal
3. Install a stainless steel cable and water-resistant lock for the fulcrum
Estimated Cost: \$100
