City of Enumclaw Pool Evaluation

October, 2017

*Prepared by:
Aquatic Commercial Consulting
Richard A. Young, Aquatic Consultant
408-741-5871 // richy@aquacom.us*

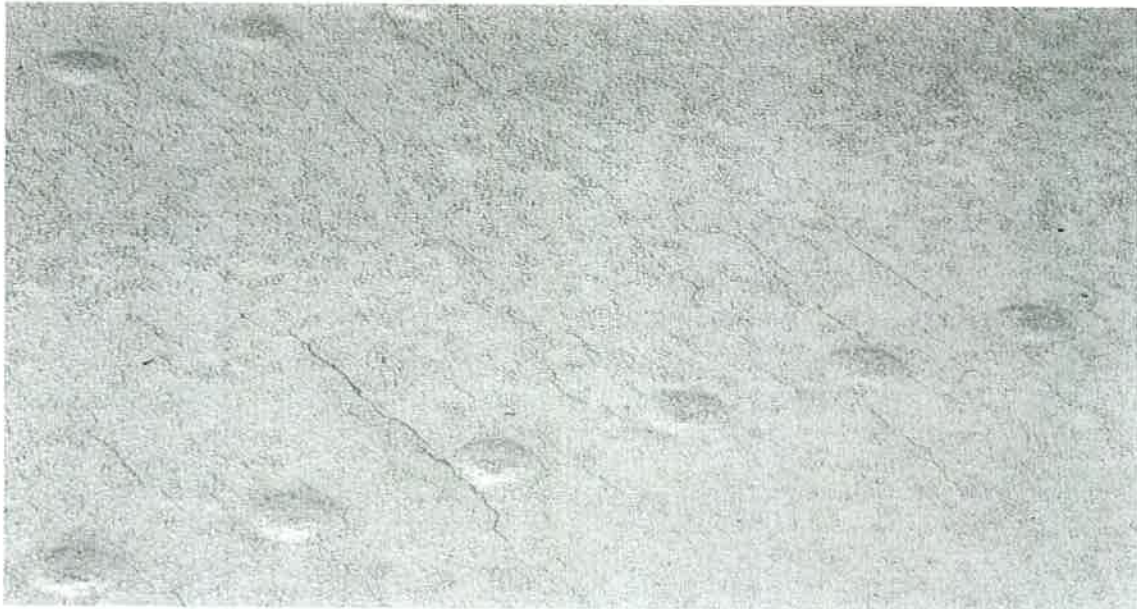
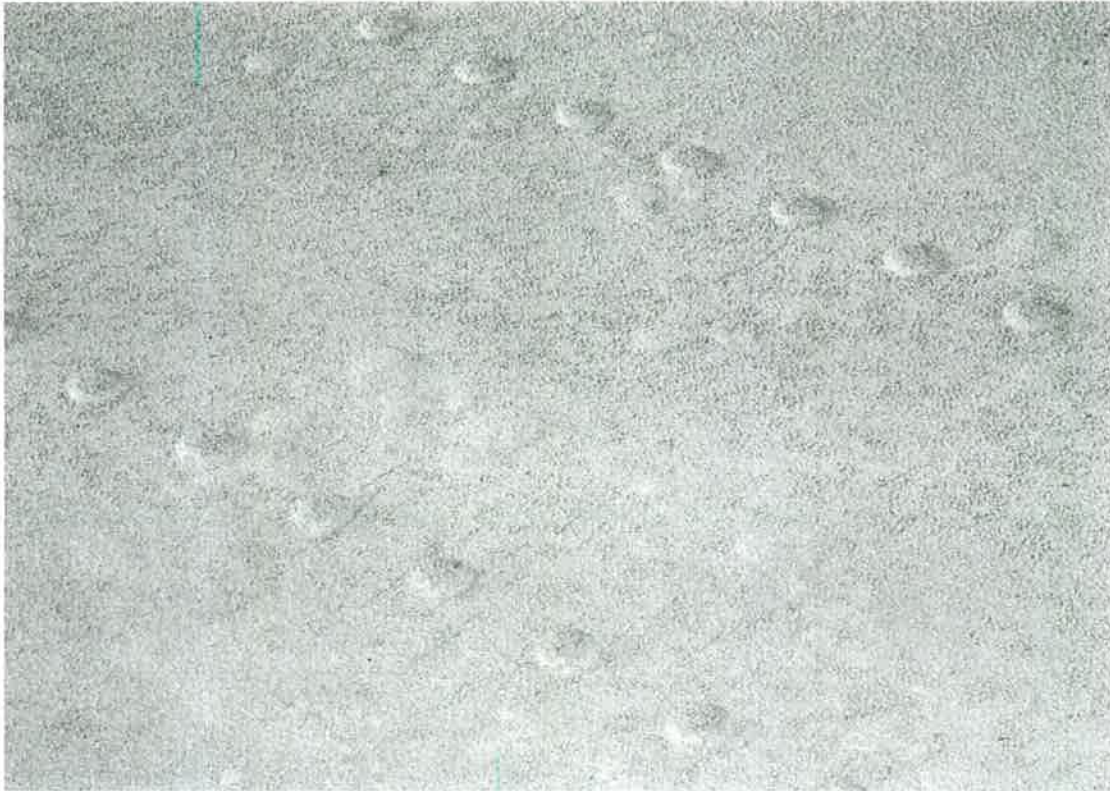
19. The diving board surface is delaminating and part of the board coating is peeling.

1. Remove and send the board back to Duraflex to have it re-surfaced
Estimated Cost: \$ 3,000
2. Lubricate the board hinges and fulcrum
Estimated Cost: Nominal
3. Install a stainless steel cable and water-resistant lock for the fulcrum
Estimated Cost: \$100

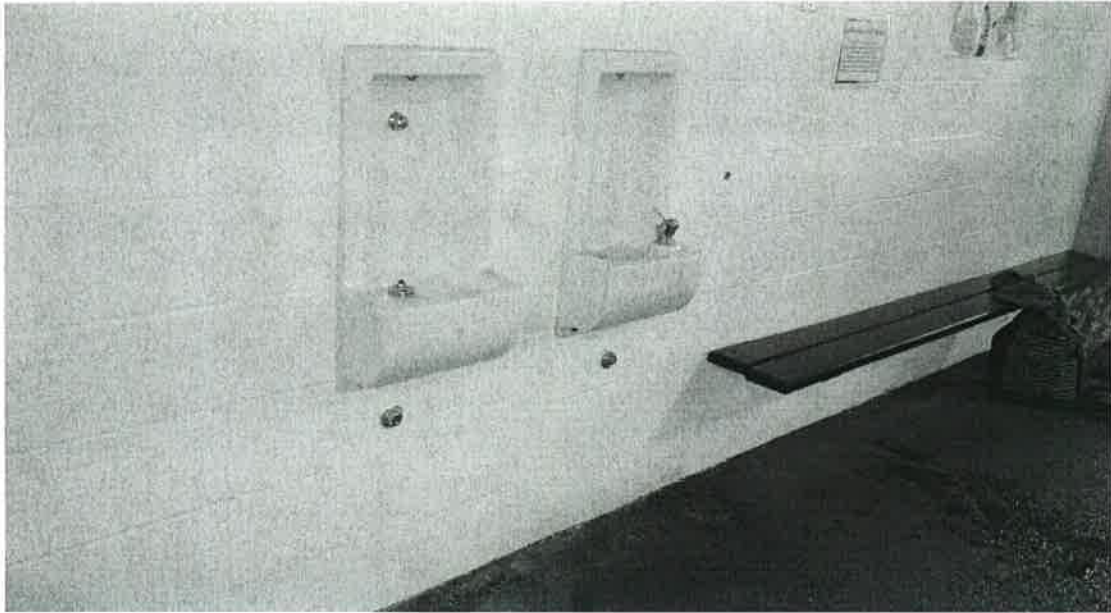
21. The drinking fountains located on the deck are not ADA compliant.

Recommendation: Install a new ADA compliant drinking fountain

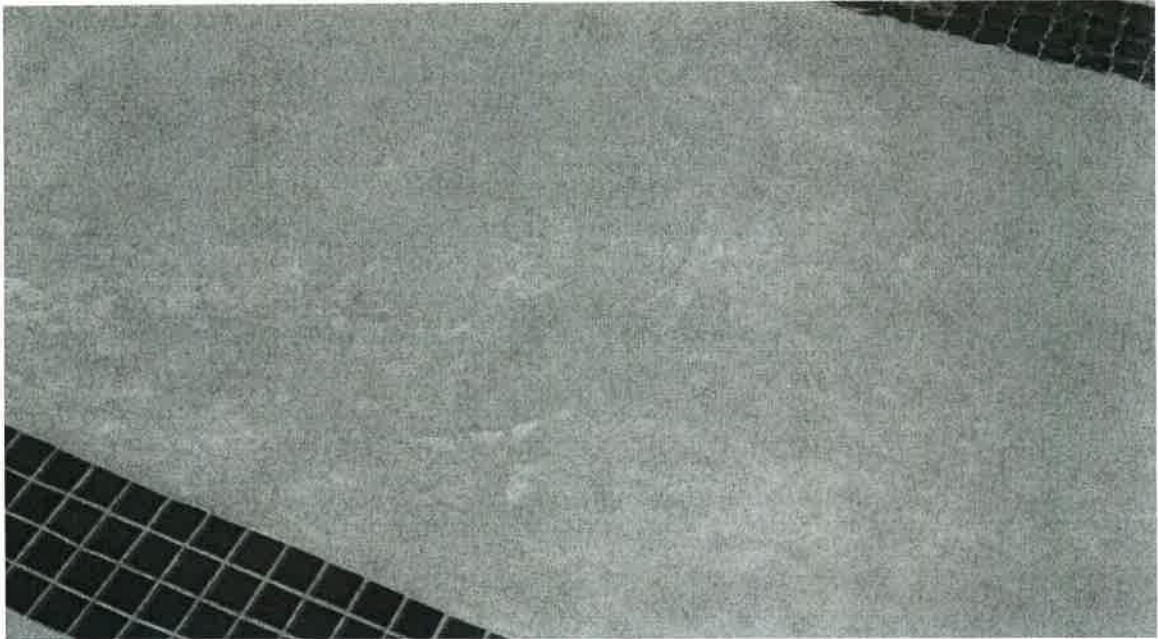
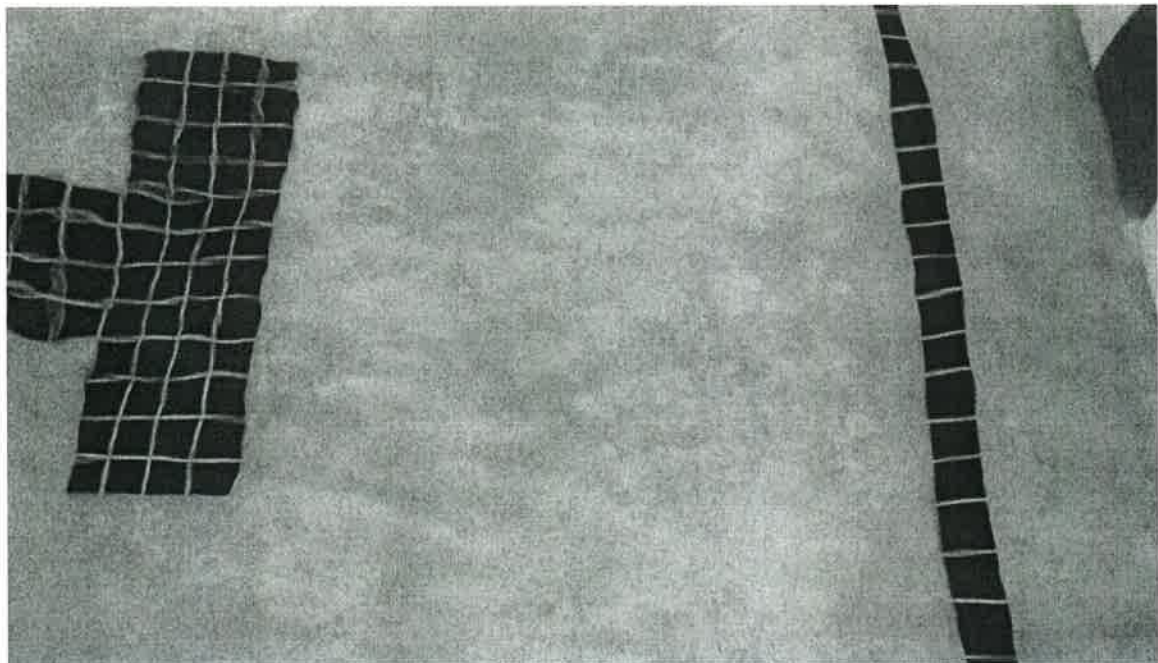
1. The pool plaster is well stained and has several areas with plaster patches. Plaster cracks and several voids are visibly evident.

1. The listed issues make it clear the pool is ready for re-coating.
2. The repairs to the steps can be completed at that time, or can be repaired under water by an experienced diver.
3. The repairs to the “bleeding” rebar must also be addressed.
The rebar must be fully exposed, wire brushed and ground to bare metal and epoxy coated. Once cured, the area patched with plaster or non-shrink grout. This can be accomplished underwater by an experienced diver.
4. Remove one row of tile around the gutter lip on the gutter side and grind smith to provide an industry compliant hand hold.
5. Remove all old plaster and re-plaster the entire pool, re-grouting all tile surfaces.

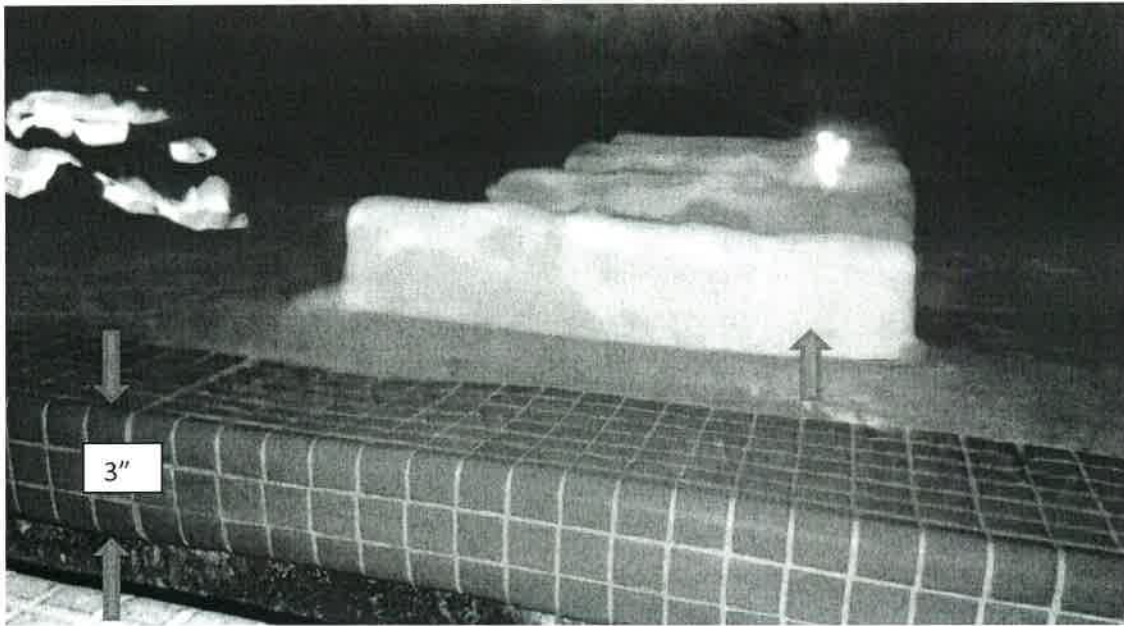
2. In at least one area that was visible, the steel rebar has “bled” through the plaster indicating the water barrier integrity has failed. Such a failure will allow water to penetrate the concrete, corrode the steel reinforcement. This corrosion will often travel to the adjacent rebar and over time will weaken the structural integrity of the vessel.
3. At least one of the recessed steps is broken and has been patched with epoxy.

4. The hand hold is 3” wide falling short of industry standards and the National Aquatic Health Code recommendations of a maximum of 2.5”. (see above photo)
5. The grout in the water-line and gutter tile is well stained and is missing in some areas.
6. Staff must move portable platforms in and out of the water for teaching lessons and there is a fiberglass step for those needing steps for entry and leaving the pool. This pool does not offer young children an areas to swim as the pool most shallow point is 3.5 feet which slopes to 4 feet and more. Staff expressed a desire to eliminate the fiberglass steps and also provide zero depth entry.

1. Expose and repair the rusting rebar and provide a plaster patch.
2. Replace the cracked recessed step
3. Provide a 2” wide hand hold on the gutter rim

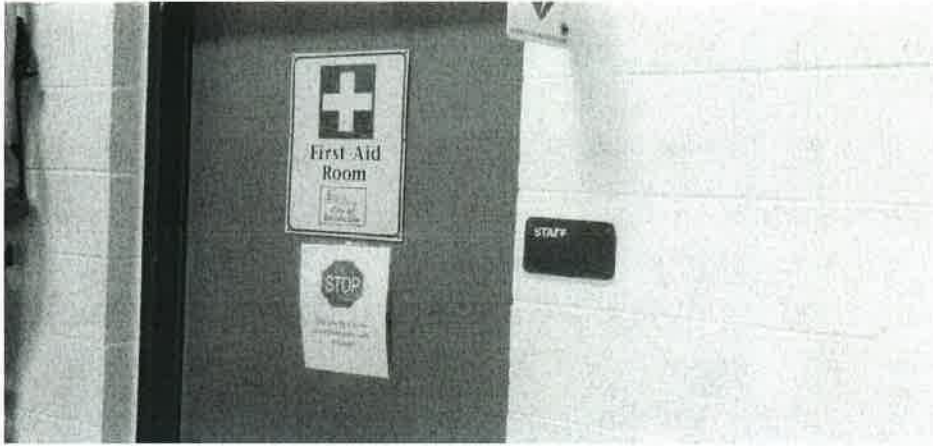
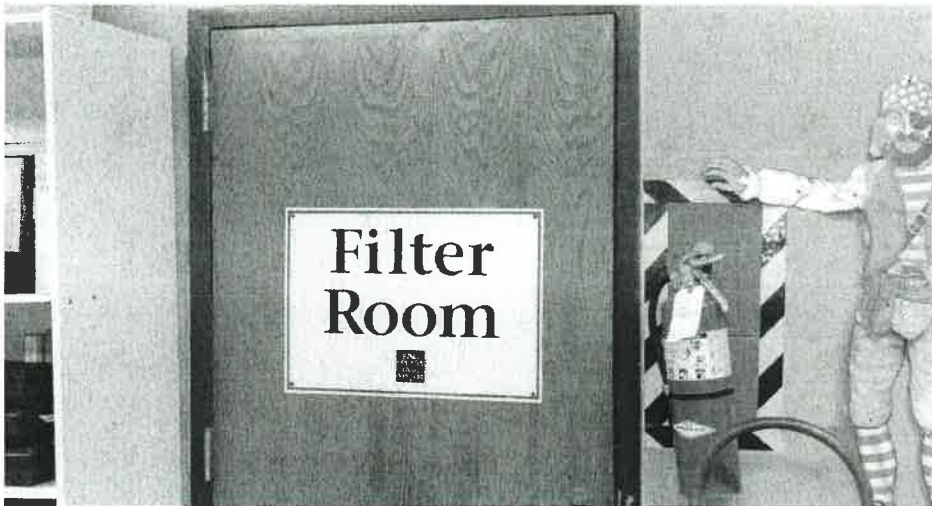
1. The doors to the electrical room, chemical storage area, filter/surge pit are not marked clearly as an “authorized personnel” only designation per IS and WOSHA. Hazardous chemicals are stored and used inside the mechanical room spaces. The doors from the pool deck into the mechanical area or from the outside do not carry the required UFC safety placards.

Recommendation: Install appropriate safety/warning signs and UFC/WOSHA mandated placards on all doors entering the pool mechanical/filter room.

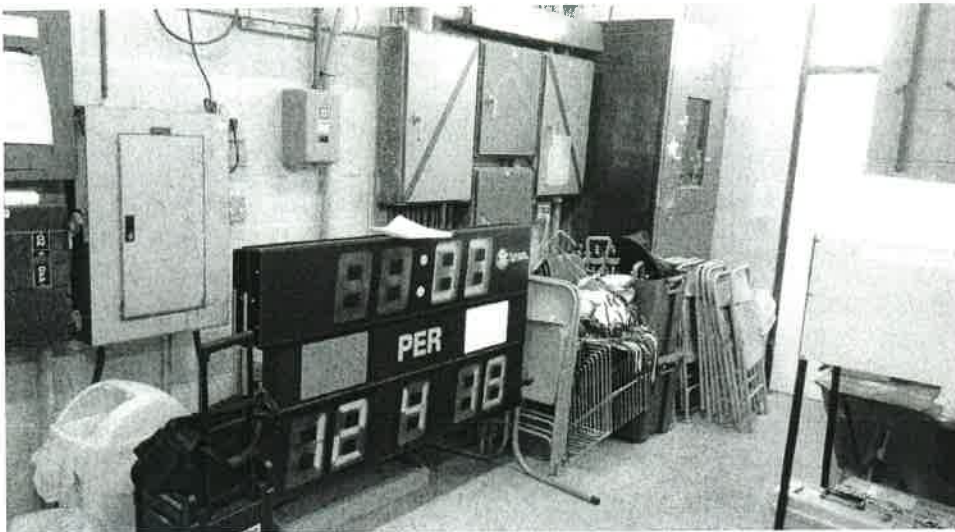
2. The electrical panel is blocked with various equipment in storage and other items contrary to NEC, IS and WOSHA.

Recommendation: Remove the equipment and other materials from in front of the electrical panel and store elsewhere.

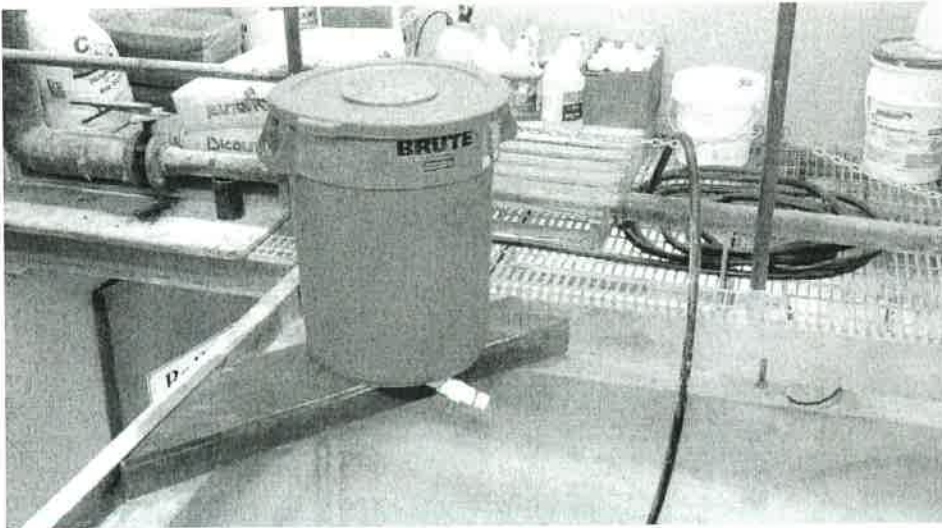
4. The D.E. pre-coat tank is comprised of a converted 50 gallon trash can.

Recommendation: Install a new fiberglass or polyethylene tank of approximately 150 to 200 gallons with a 2" drain valve for pre-coating the filters, a slow speed mixer and industrial-grade solution feed pump with an automatic flush device to "body" feed D.E. into the surge/filter pit 24 hours per day.

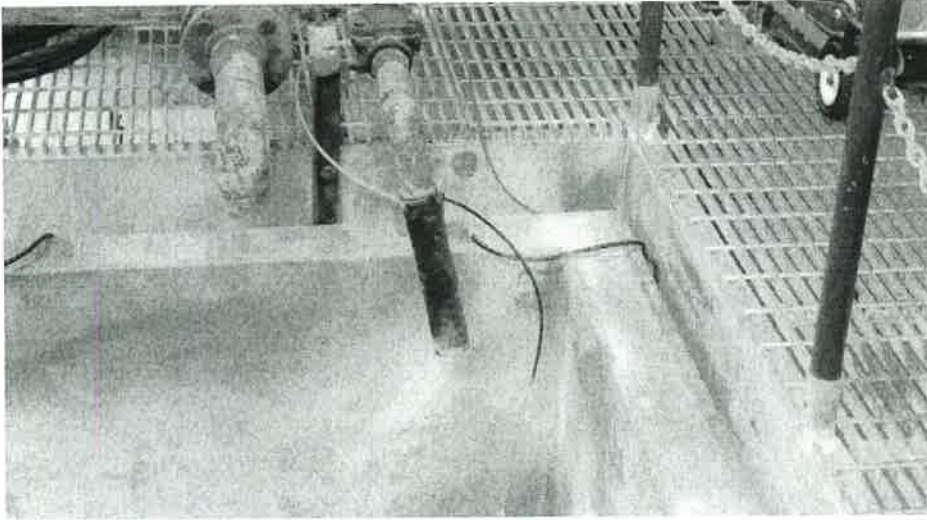
6. The automatic fill system makes use of a simple float valve assembly and Cla-Valve, however, the discharge into the pit is located well below the rim of the surge pit and is in violation of WAC and NPC and IS. NPC and WAC call for an air gap between the fill line and the highest pit level possible to insure no pool water can mix with the domestic water source in the event of a domestic water line failure (siphon back pool water).

Recommendation: Extend the fill line further over the tank edge and reduce the vertical line so to insure the pipe end provides a 2" air gap between the tank and the pipe.

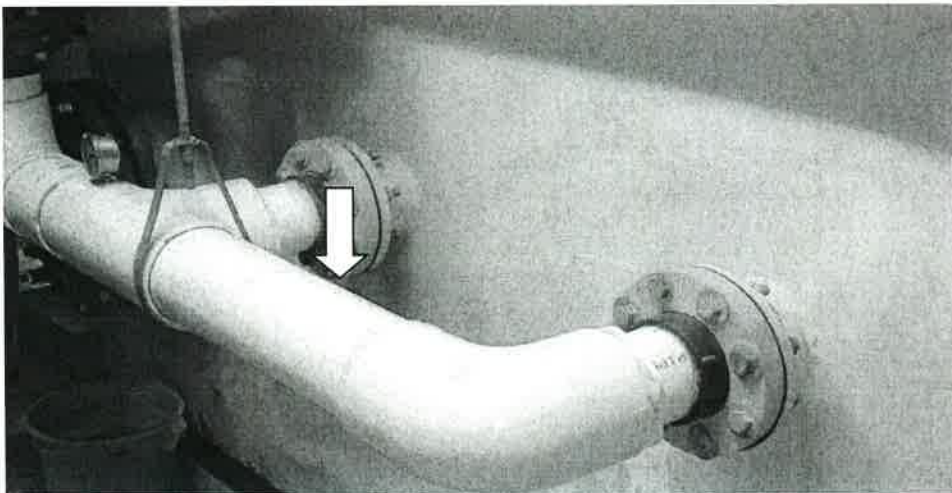
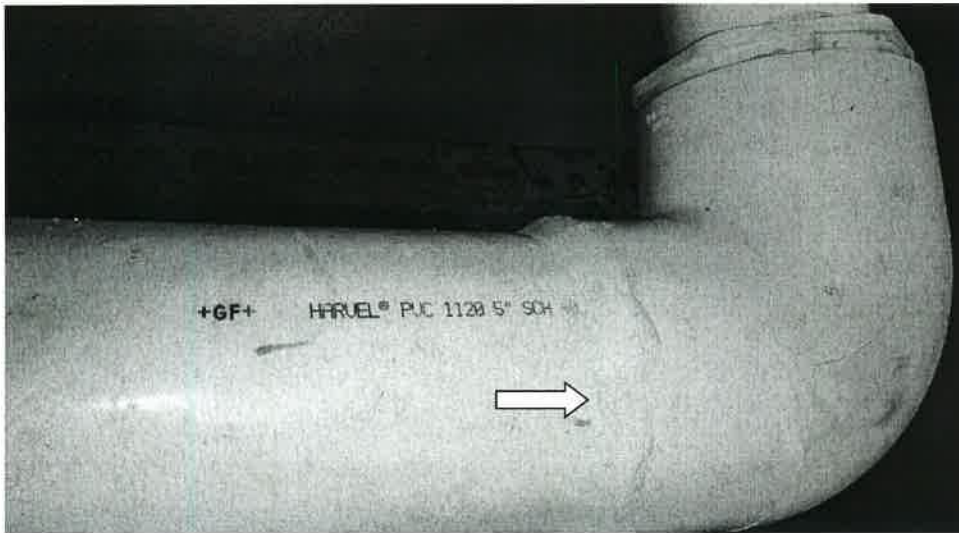
This manifold has also developed a leak which has been patched with epoxy.

Recommendation: Install a new 6" manifold with 6" x 4" tee and 90 degree elbow to decrease the suction velocity to below 6 feet per second. Connect to the pump with a concentric reducer to the 5" flange at the pump. With the limited space this will require some additional plumbing to achieve the proper plumbing connections.

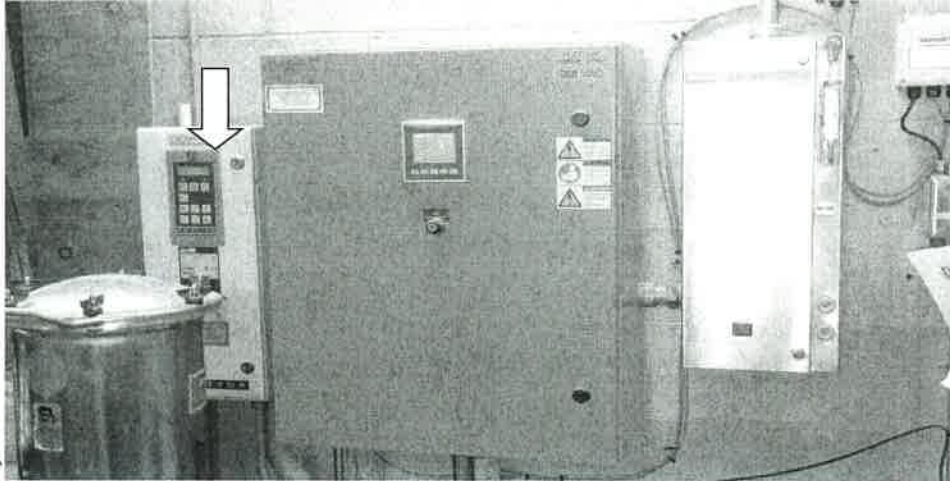
9. The pump Variable Frequency Drive (VFD) control is programmed presently to operate the recirculation pump at 1,278 RPM. The pump has the capacity to operate at 1,750 RPM and should have the capacity to increase the recirculation flow rate to achieve the filter maximum filter capacity and WAC required recirculation flow rate. However, the 5 inch suction manifold and the pump discharge plumbing presents a bottleneck that may prevent this from occurring. (see also comments concerning filter size in item #8)

Recommendation: Upon increasing the pump suction manifold and discharge plumbing changes, reprogram the VFD to operate at a higher RPM to achieve the 680 GPM WAC-required recirculation flow rate.

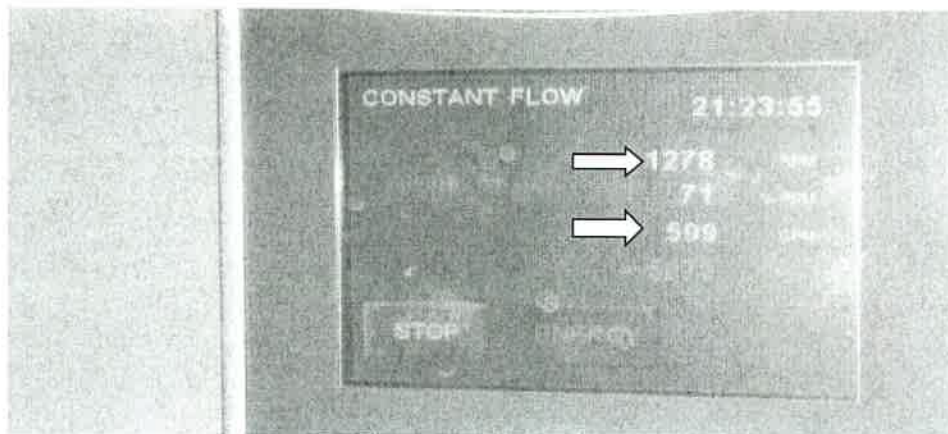
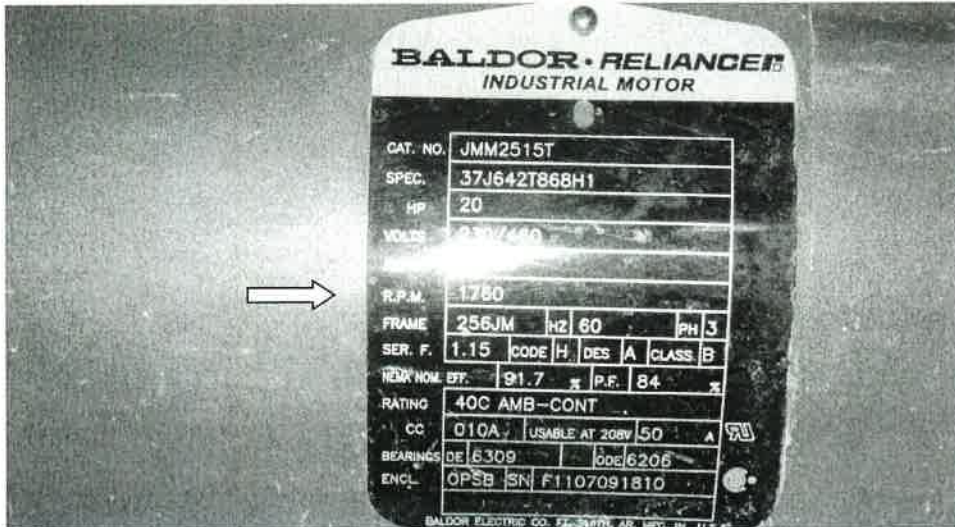
10. The existing flow indicated on the pump control flow meter is approximately 600 GPM. The design recirculation flow rate to achieve the code required six hour turnover is 680 GPM. . The existing turnover is approximately 6 hours 45 minutes. The pool remains clear. Nevertheless , the existing flow rate falls short of WAC and IS.

This particular 20 HP pump is well capable of the design flow rate of 680 GPM. Again the pump RPM setting and the bottle-neck created by the five inch suction manifold could very well be the difference in flow.

11. According to this display, the pump is only operating at 1,278 RPM, yet is capable of 1,750 RPM allowing for a higher flow that may very well achieve the WAC required flow rate to achieve the six hour turnover.

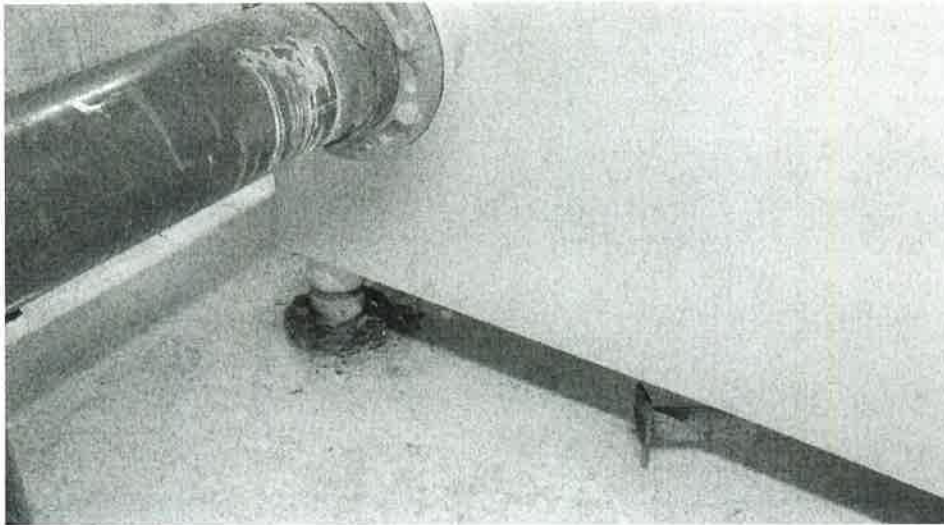
The filter/surge tank is a coated steel tank that appears to be in good shape, however, this tank sits on flanged supports onto the concrete floor. The supports are significantly corroded.

Recommendation: Remove the rust and corrosion and inspect the flange supports for integrity. Paint the flanges and supports with an epoxy paint to protect them from further corrosion. Replace them and the concrete anchors if necessary.

- Clean, inspect and paint: Nominal
- Replace the flanges and anchors: \$1,400

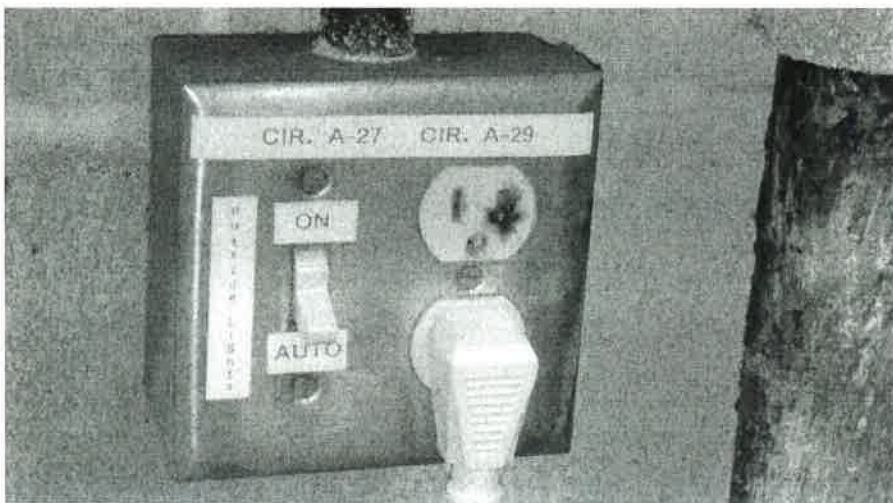
12. There is a junction box for the outside lights in the mechanical room that has a non-GFCI receptacle. This receptacle shows signs of an electrical short, however, staff did not know if the short had been repaired. This does not appear to be GFCI protected.

Recommendation: Investigate the short, make repairs and insure the receptacle is GFCI protected either by installing an GFCI receptacle or breaker with a proper label located at the receptacle.

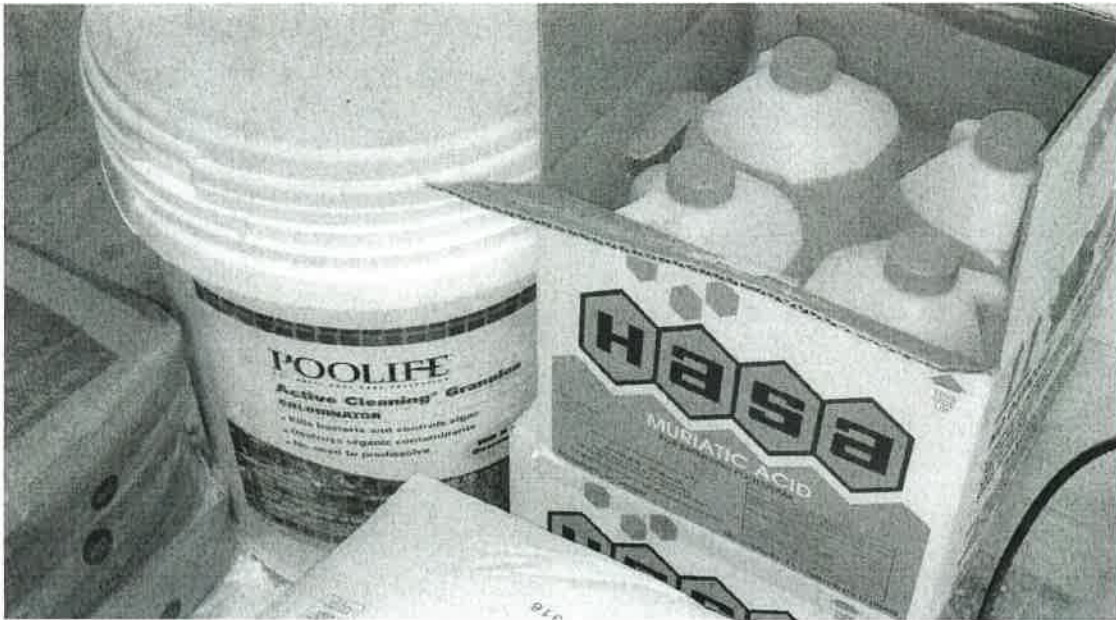
13. There are dissimilar chemicals (chlorine, muriatic acid, sodium bicarbonate and cleaning chemicals) stored side by side on the mechanical room floor. WOSHA, and UFC call for such chemicals to be stored separately. The acid should be stored on a double contained floor pallet.

Recommendations: Separate and properly store chemicals per the Material Safety Data Sheets, UFC-80 and IS. Purchase and make use of containment pallets for acids and other liquids. An approved organic vapor mask was not evident.

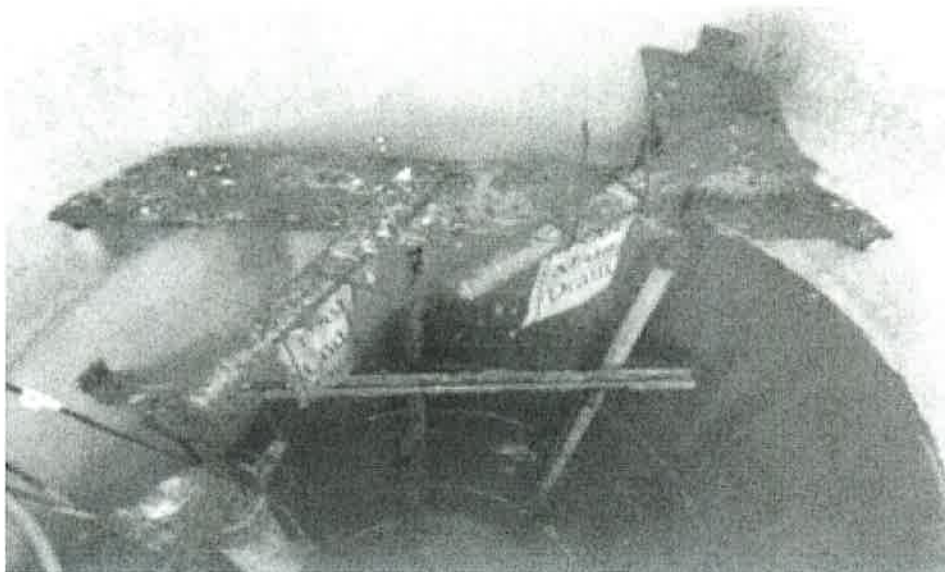
1. Pool Drain valves handles: There are drain valves located outside of the facility in a drain vault of which the handles are completely corroded and are in operable unless maintenance staff climb into the vault and operate the valves from below.

Recommendations: Replace the valves and valve handles with stainless steel units.
